KENNEBUNKPORT ZONING BOARD OF APPEALS
Administrative Appeal Application

Reason for Appeal: Lifting of Suspension of Permits without all corrective measures ordered being taken:

- (1) Resubmitted plot plan does not show demonstrate no increase in lot coverage. (2) Wall section A11 not built per submitted plans, and not to code. (3) Construction of rock walls A2 and A1 appears haphazard, and not to code.
(4) Unauthorized and unlawful work, including patio structure must be corrected. See Addendum for details as to 1-4.

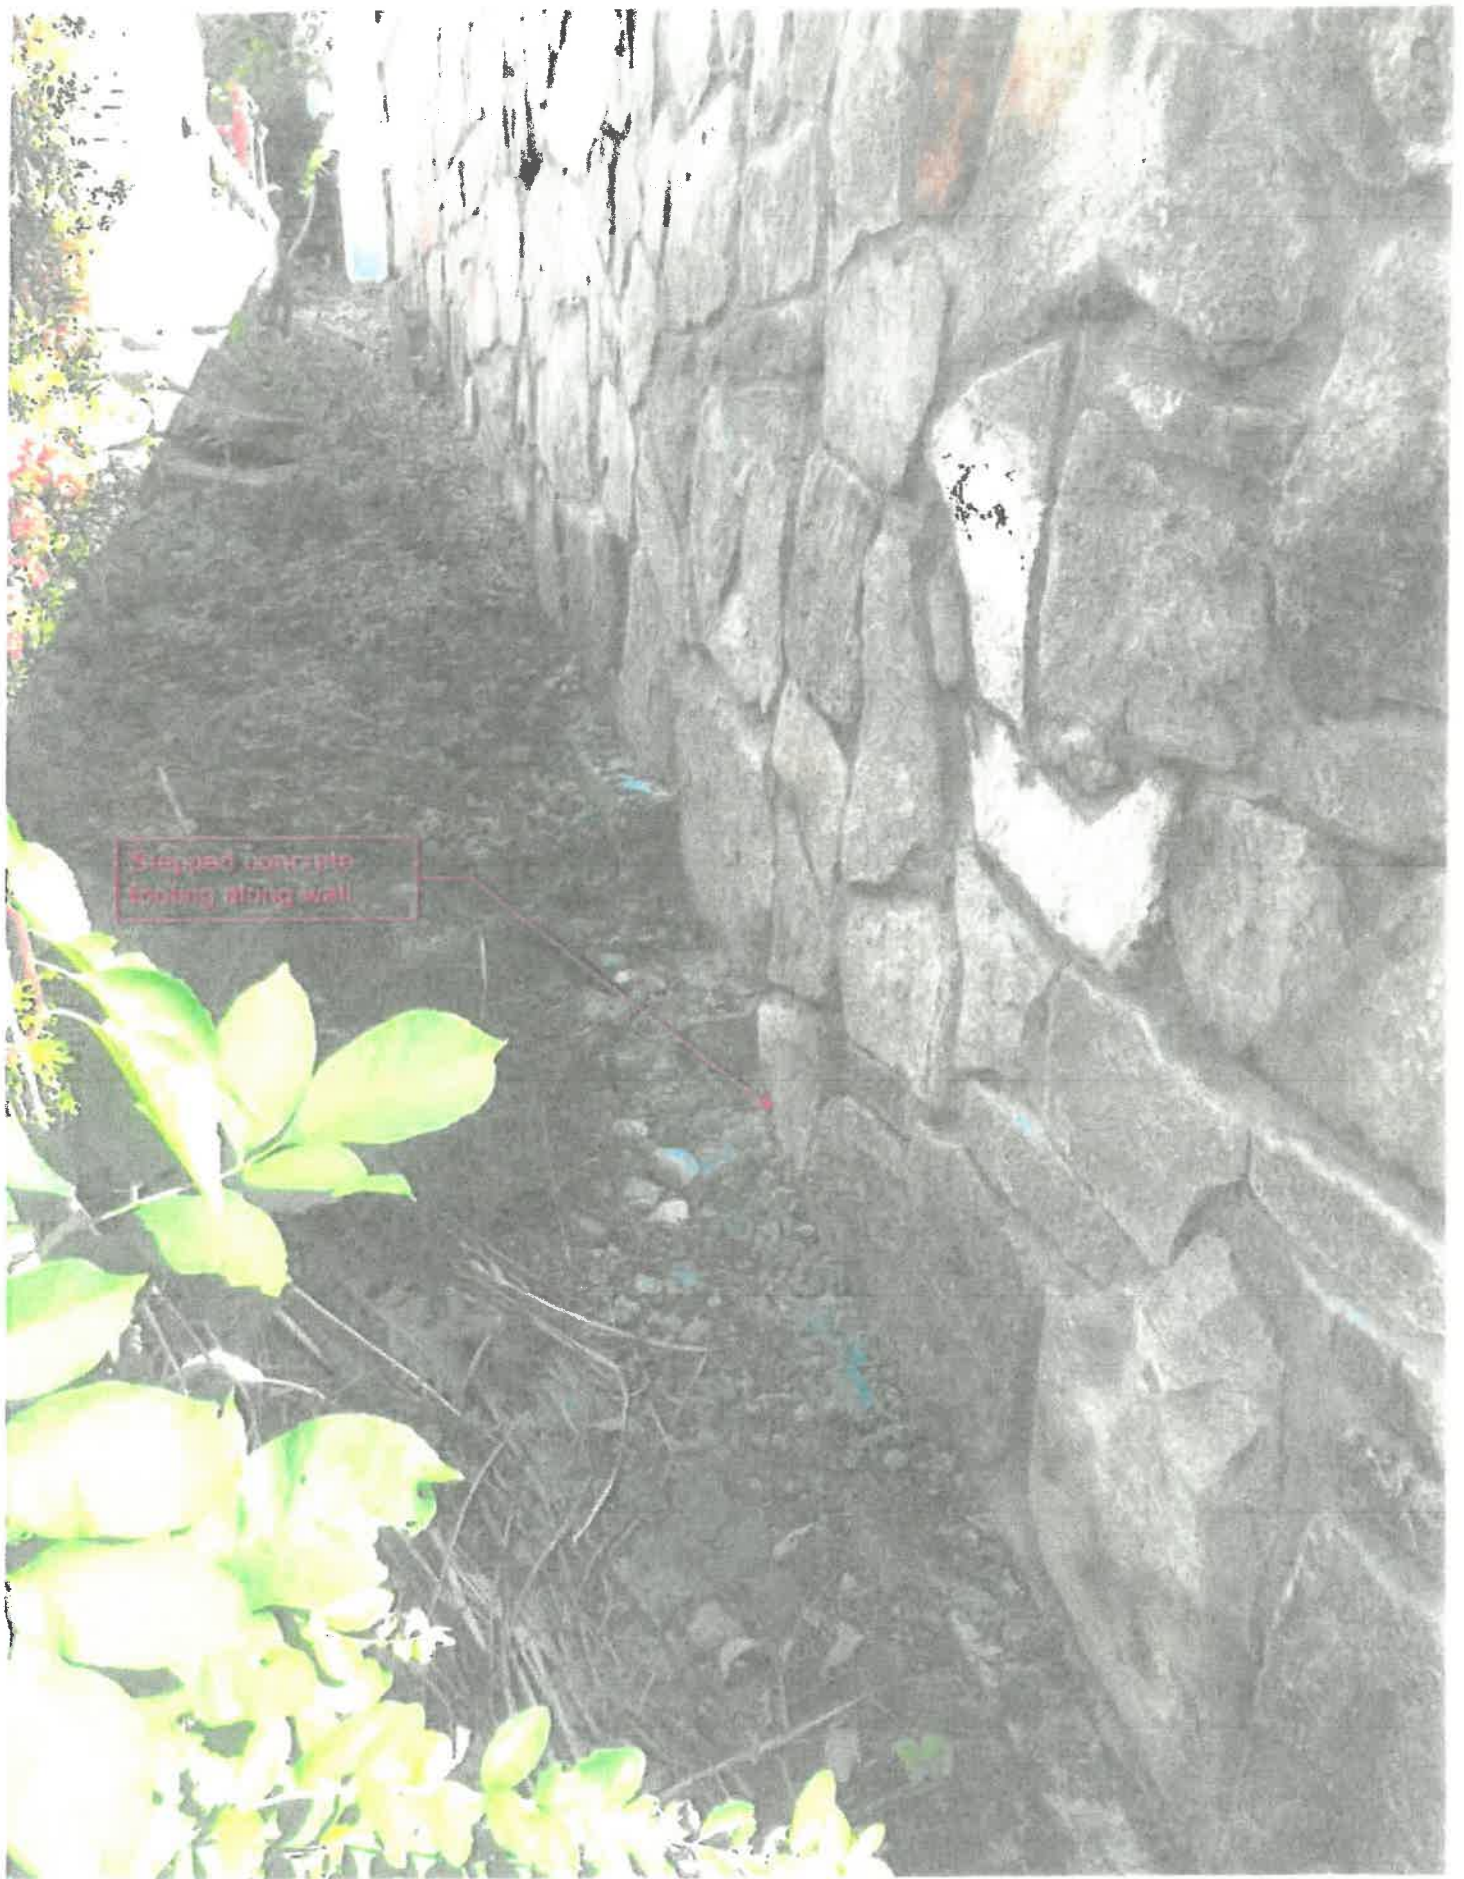
Stepped concrete
looking along wall

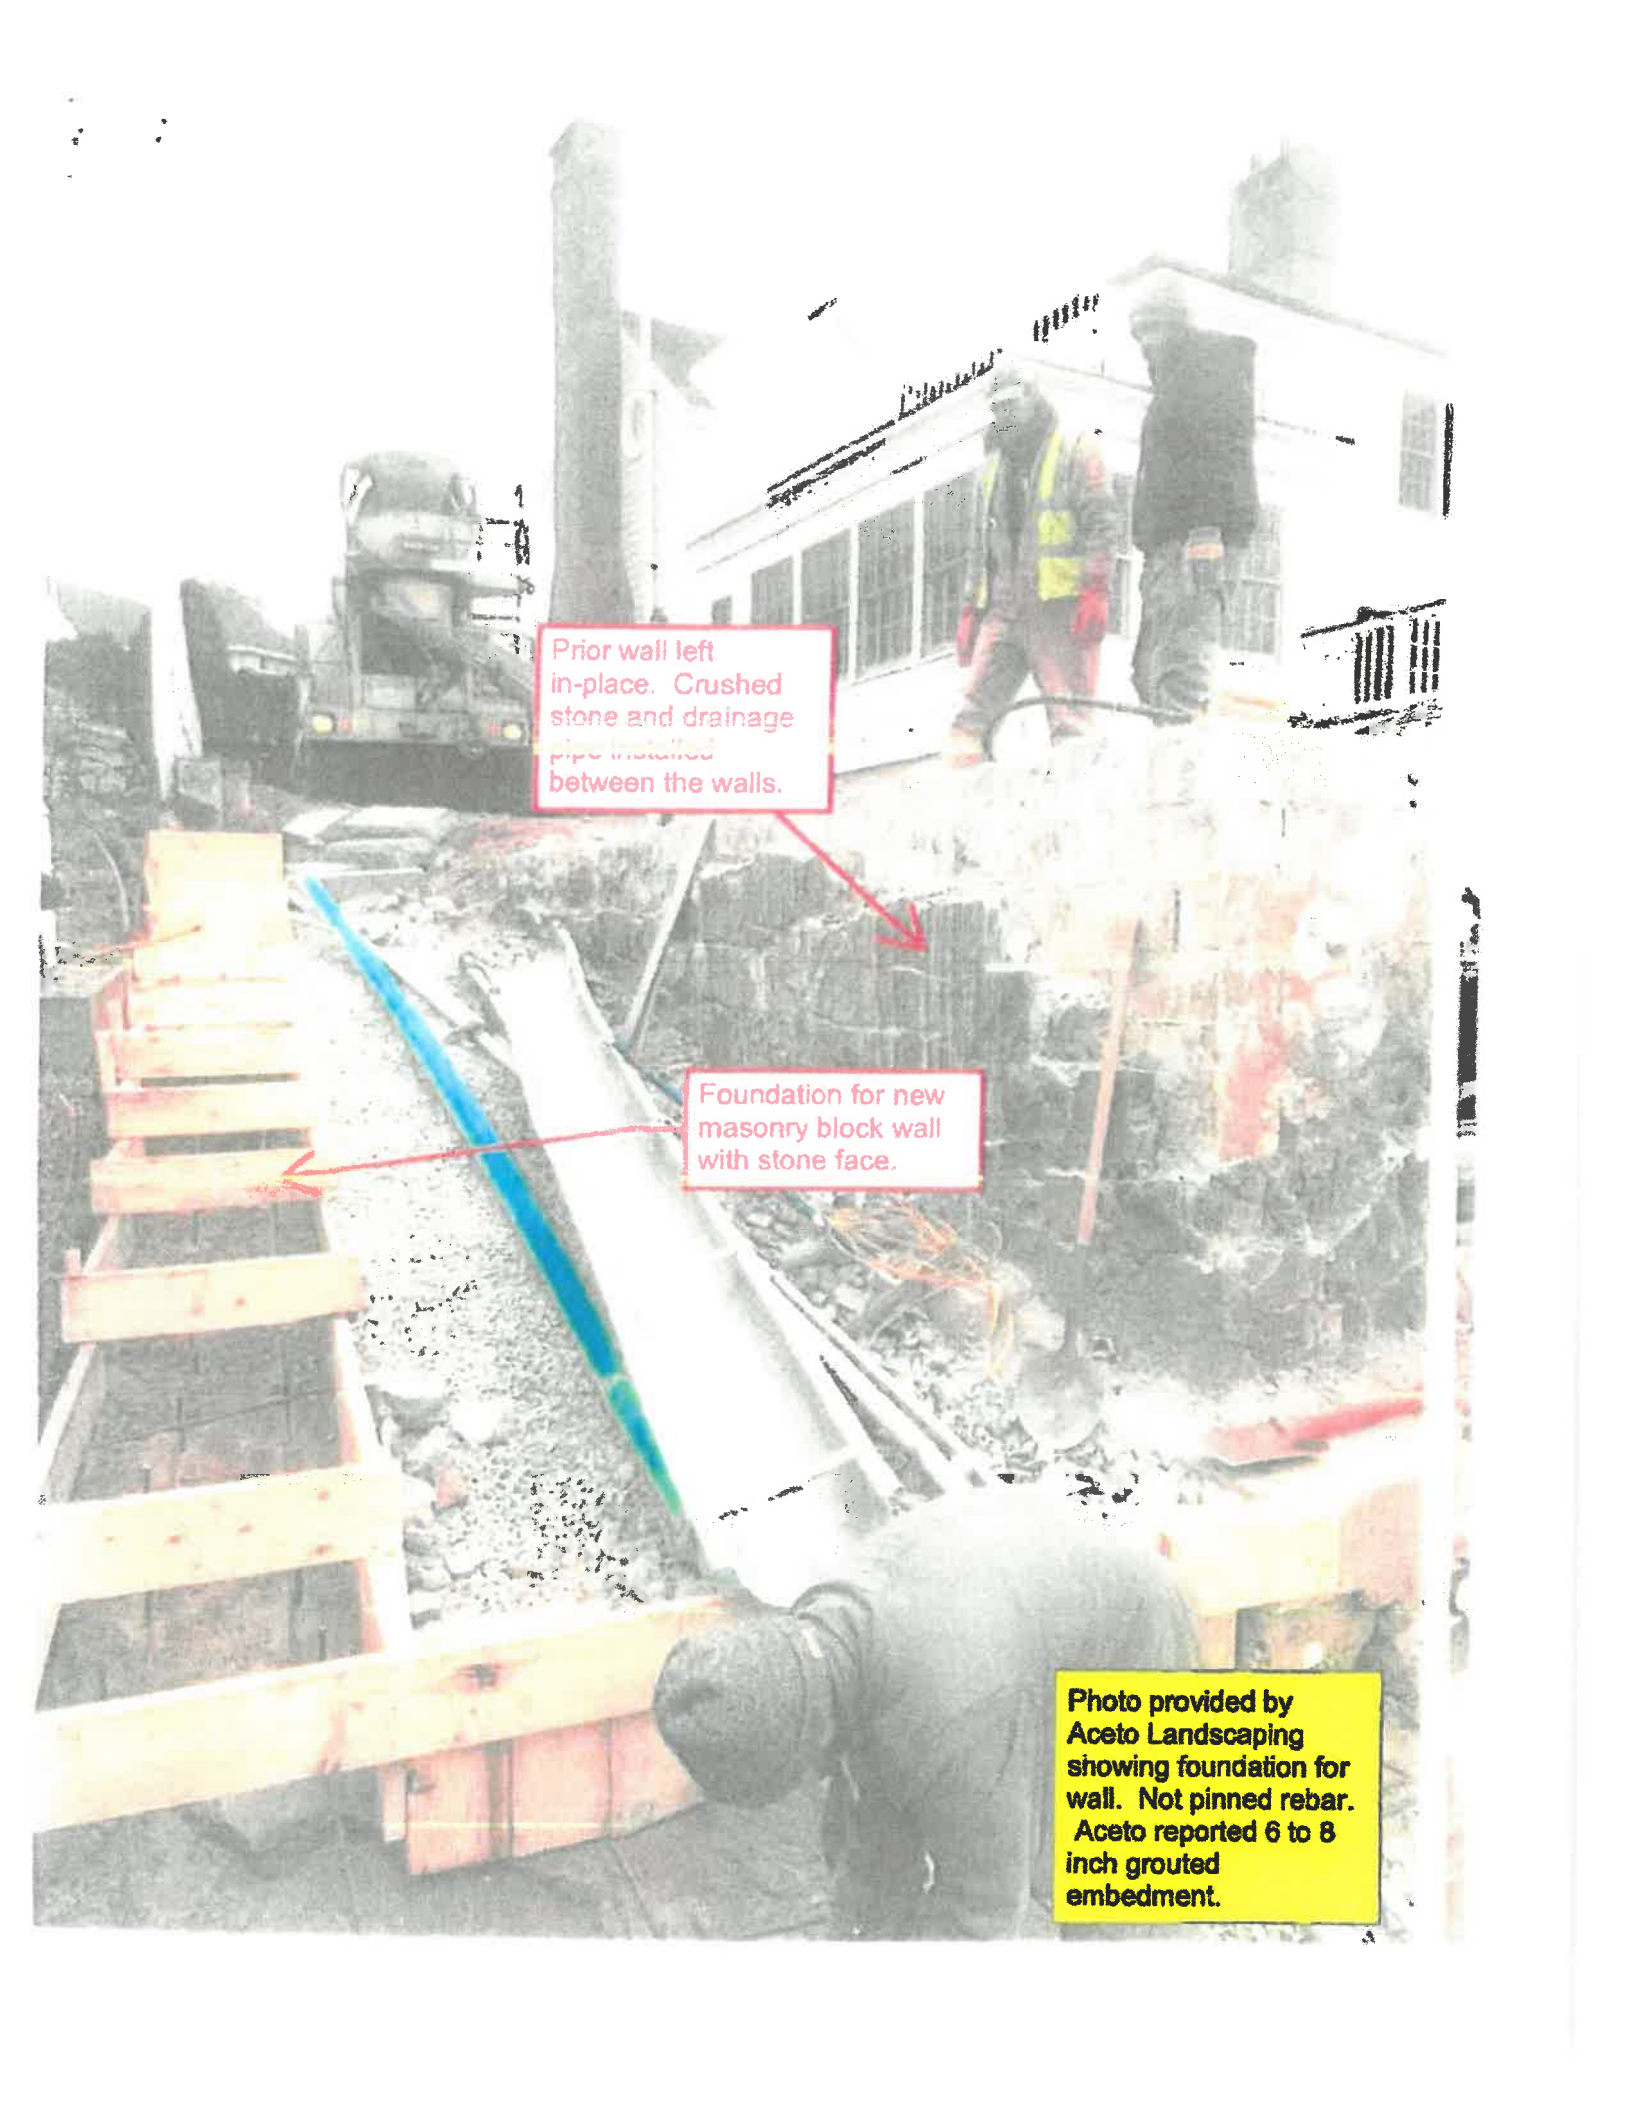
Prior wall left
in-place. Crushed
stone and drainage
pipe installed
between the walls.

Foundation for new
masonry block wall
with stone face.

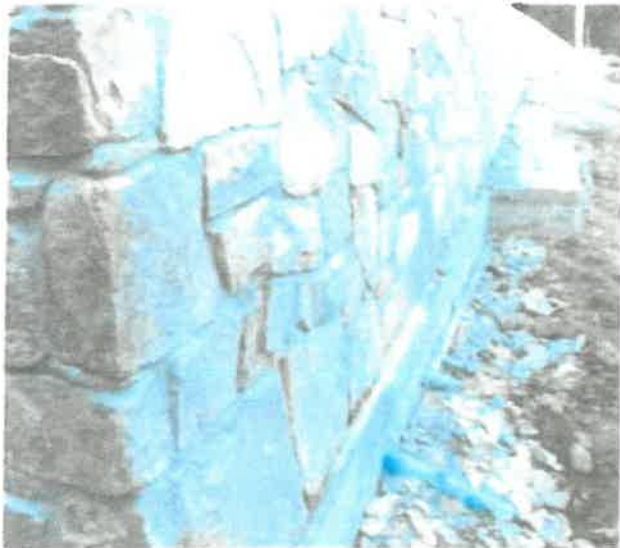
CMU wall: southwest corner drain outlet

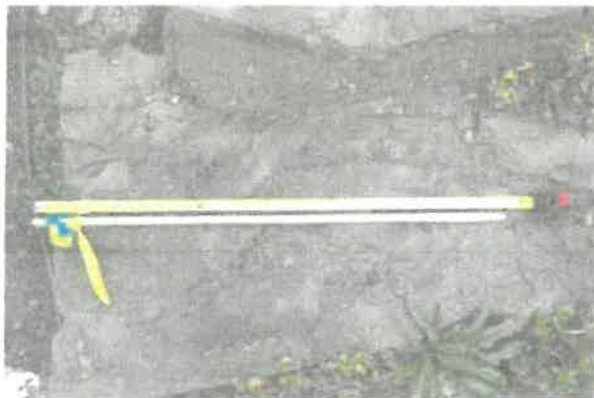
Photo #1 – 34" long Probe #1

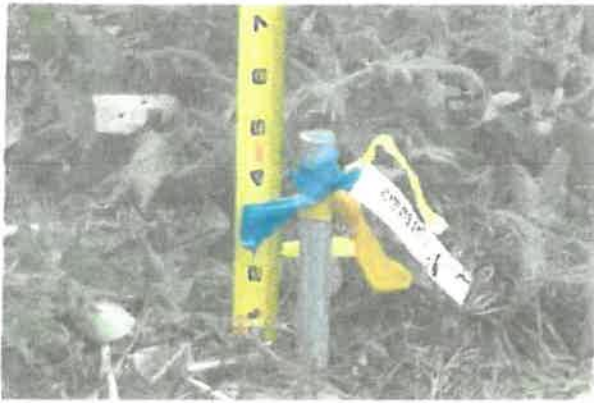
Photo #3 – Probe #1, ledge not found

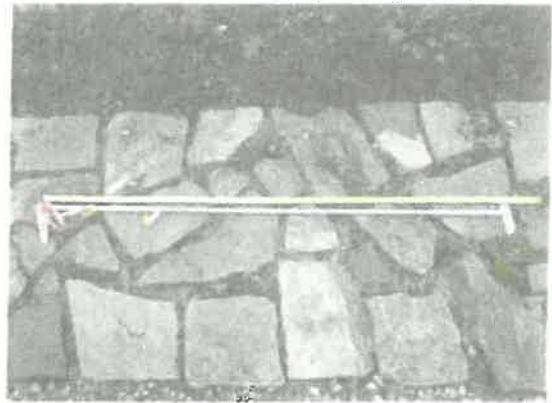
Photo #4 – 62" long Probe #2

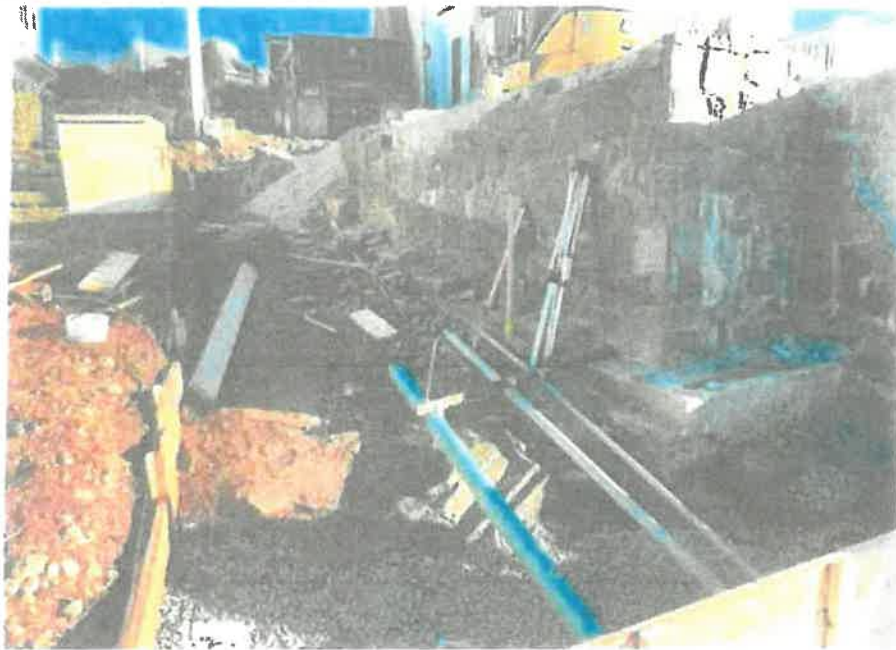
"View up property line where new wall will be installed. New drain pipe in green to connect to existing and daylight downhill. Gray sleeves for lighting and irrigation runs."

Photo #9 (by others) – Photo and caption above sent by email from Joshua Tomkins on 1/11/19 at Wall A-11. Crushed stone and formwork are clearly visible below bottom of forms. No ledge is observed or referenced in the caption. Soil compaction equipment is not observed in the photo.

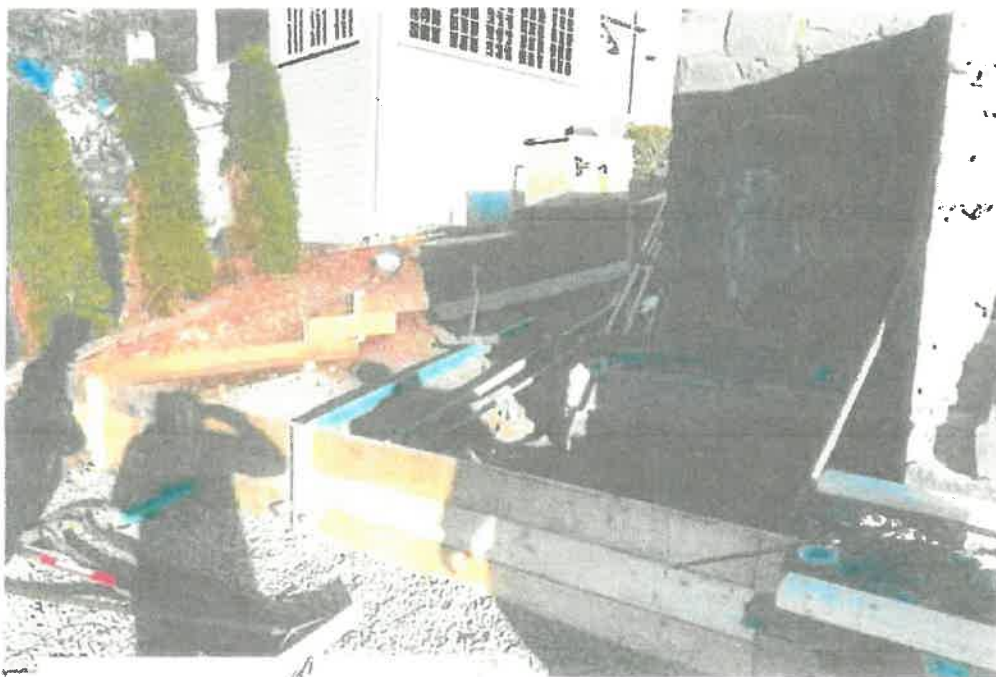
"Forms in place for footing for block wall. Scheduled to be poured next week. The purpose of these walls is to gain valuable space above for the fire pit gathering area."

Photo #10 (by others) – Photo and caption above sent by email from Joshua Tomkins on 1/11/19 at Wall A-11. Crushed stone and formwork are clearly visible below bottom of forms. No ledge is observed or referenced in the caption. Soil compaction equipment is not observed in photo.

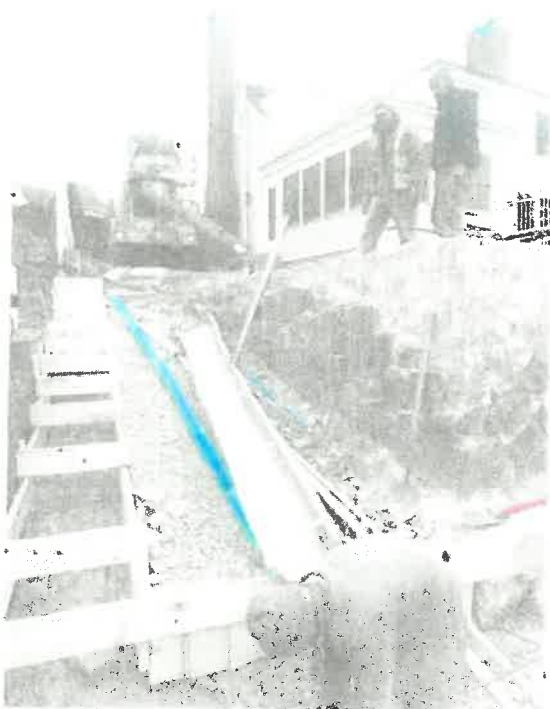
Photo #12 (by others) – Similar view as Photo #11 above, it is not clear what material the pins are embedded into. Based on Photos #9, #10, and #11, it appears doubtful that the material directly below the footing is ledge. Note location of blue underdrain is the same in both photos.

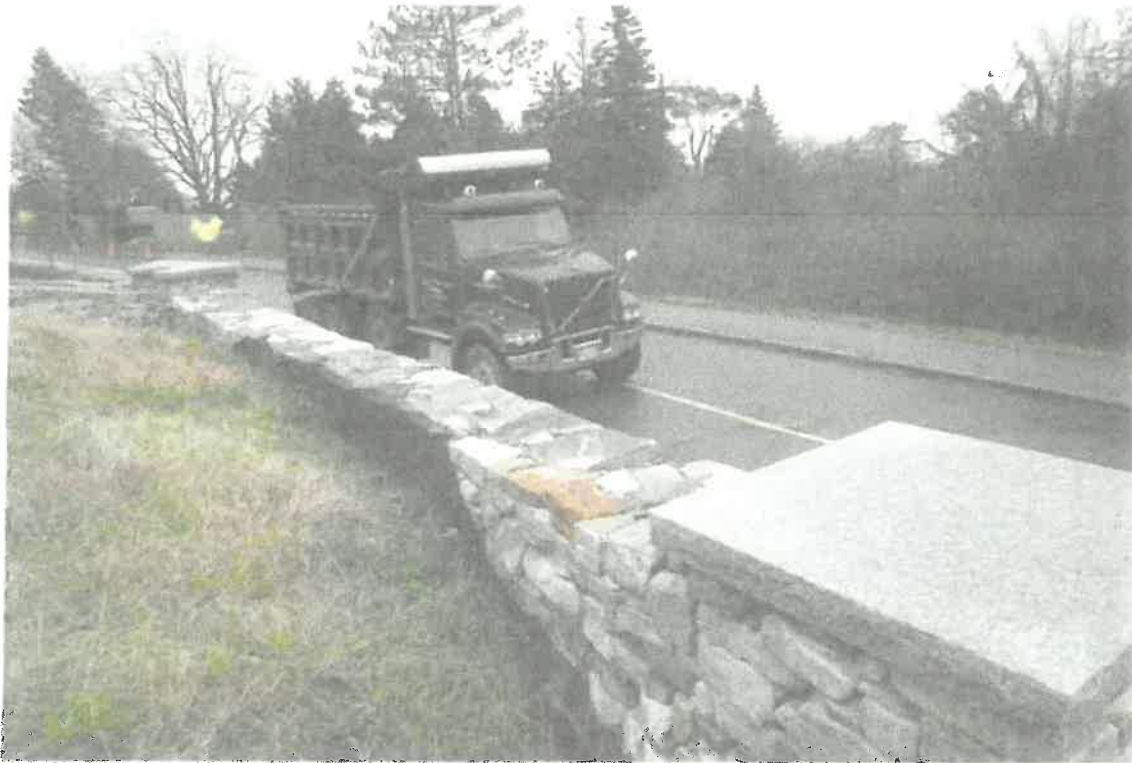
Photo #24 – Enlarged photo of A-2 rubble stone wall – No full width capstone “bonders” observed

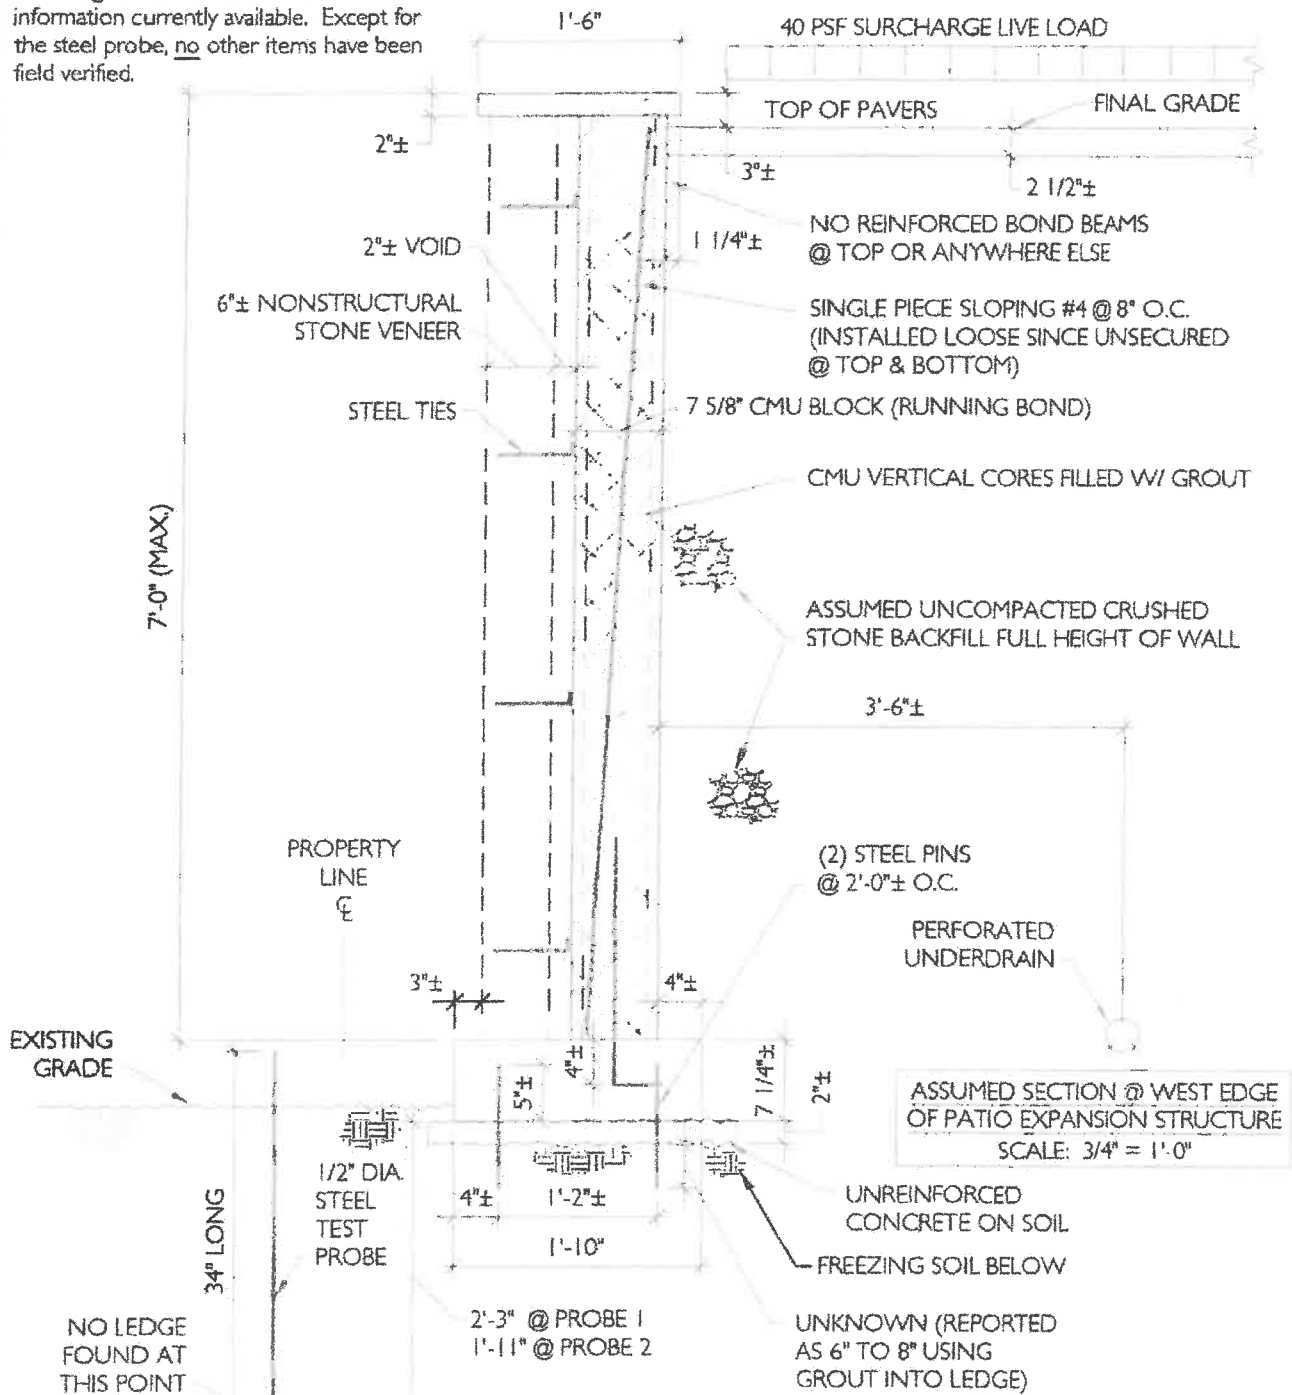
NOTE: This section indicates the assumed "As-Built" construction of the west edge of the structure based on information currently available. Except for the steel probe, no other items have been field verified.

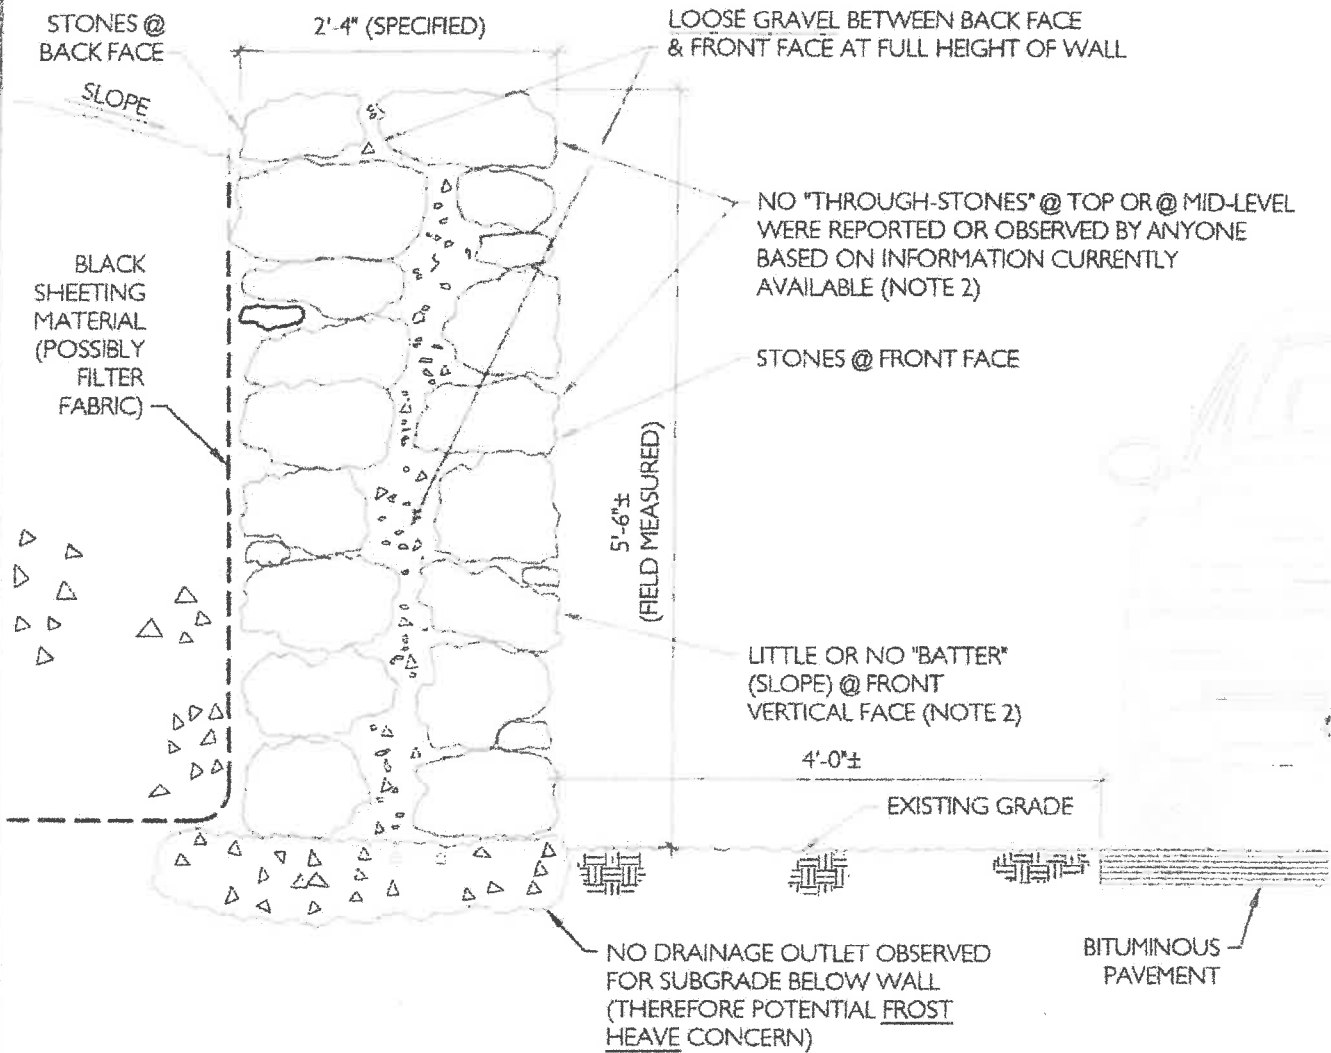
ASSUMED SECTION SOUTH
WALLS "A1" & "A2" AT ROAD
(SEE NOTE)
SCALE: 3/4" = 1'-0"

- NOTES:**
1. Based on the documents, field measurements, observations, reported information and photographs currently available, this sketch represents what is believed to be the as-built condition of the stone rubble retaining walls labeled "A1" and "A2" adjacent to Shore Road. The concern is that because there are no bondar units ("through-stones") at the top or mid-level, the stones at the front face are acting alone as a wall resisting large lateral loads and frost heave. This is because the stones at the back face provide no lateral support assistance to the stones at the front face.
 2. Lack of through-stones and missing battered front slope were reported in the 4/3/19 report by Structural Integrity Consulting Engineers, Inc.

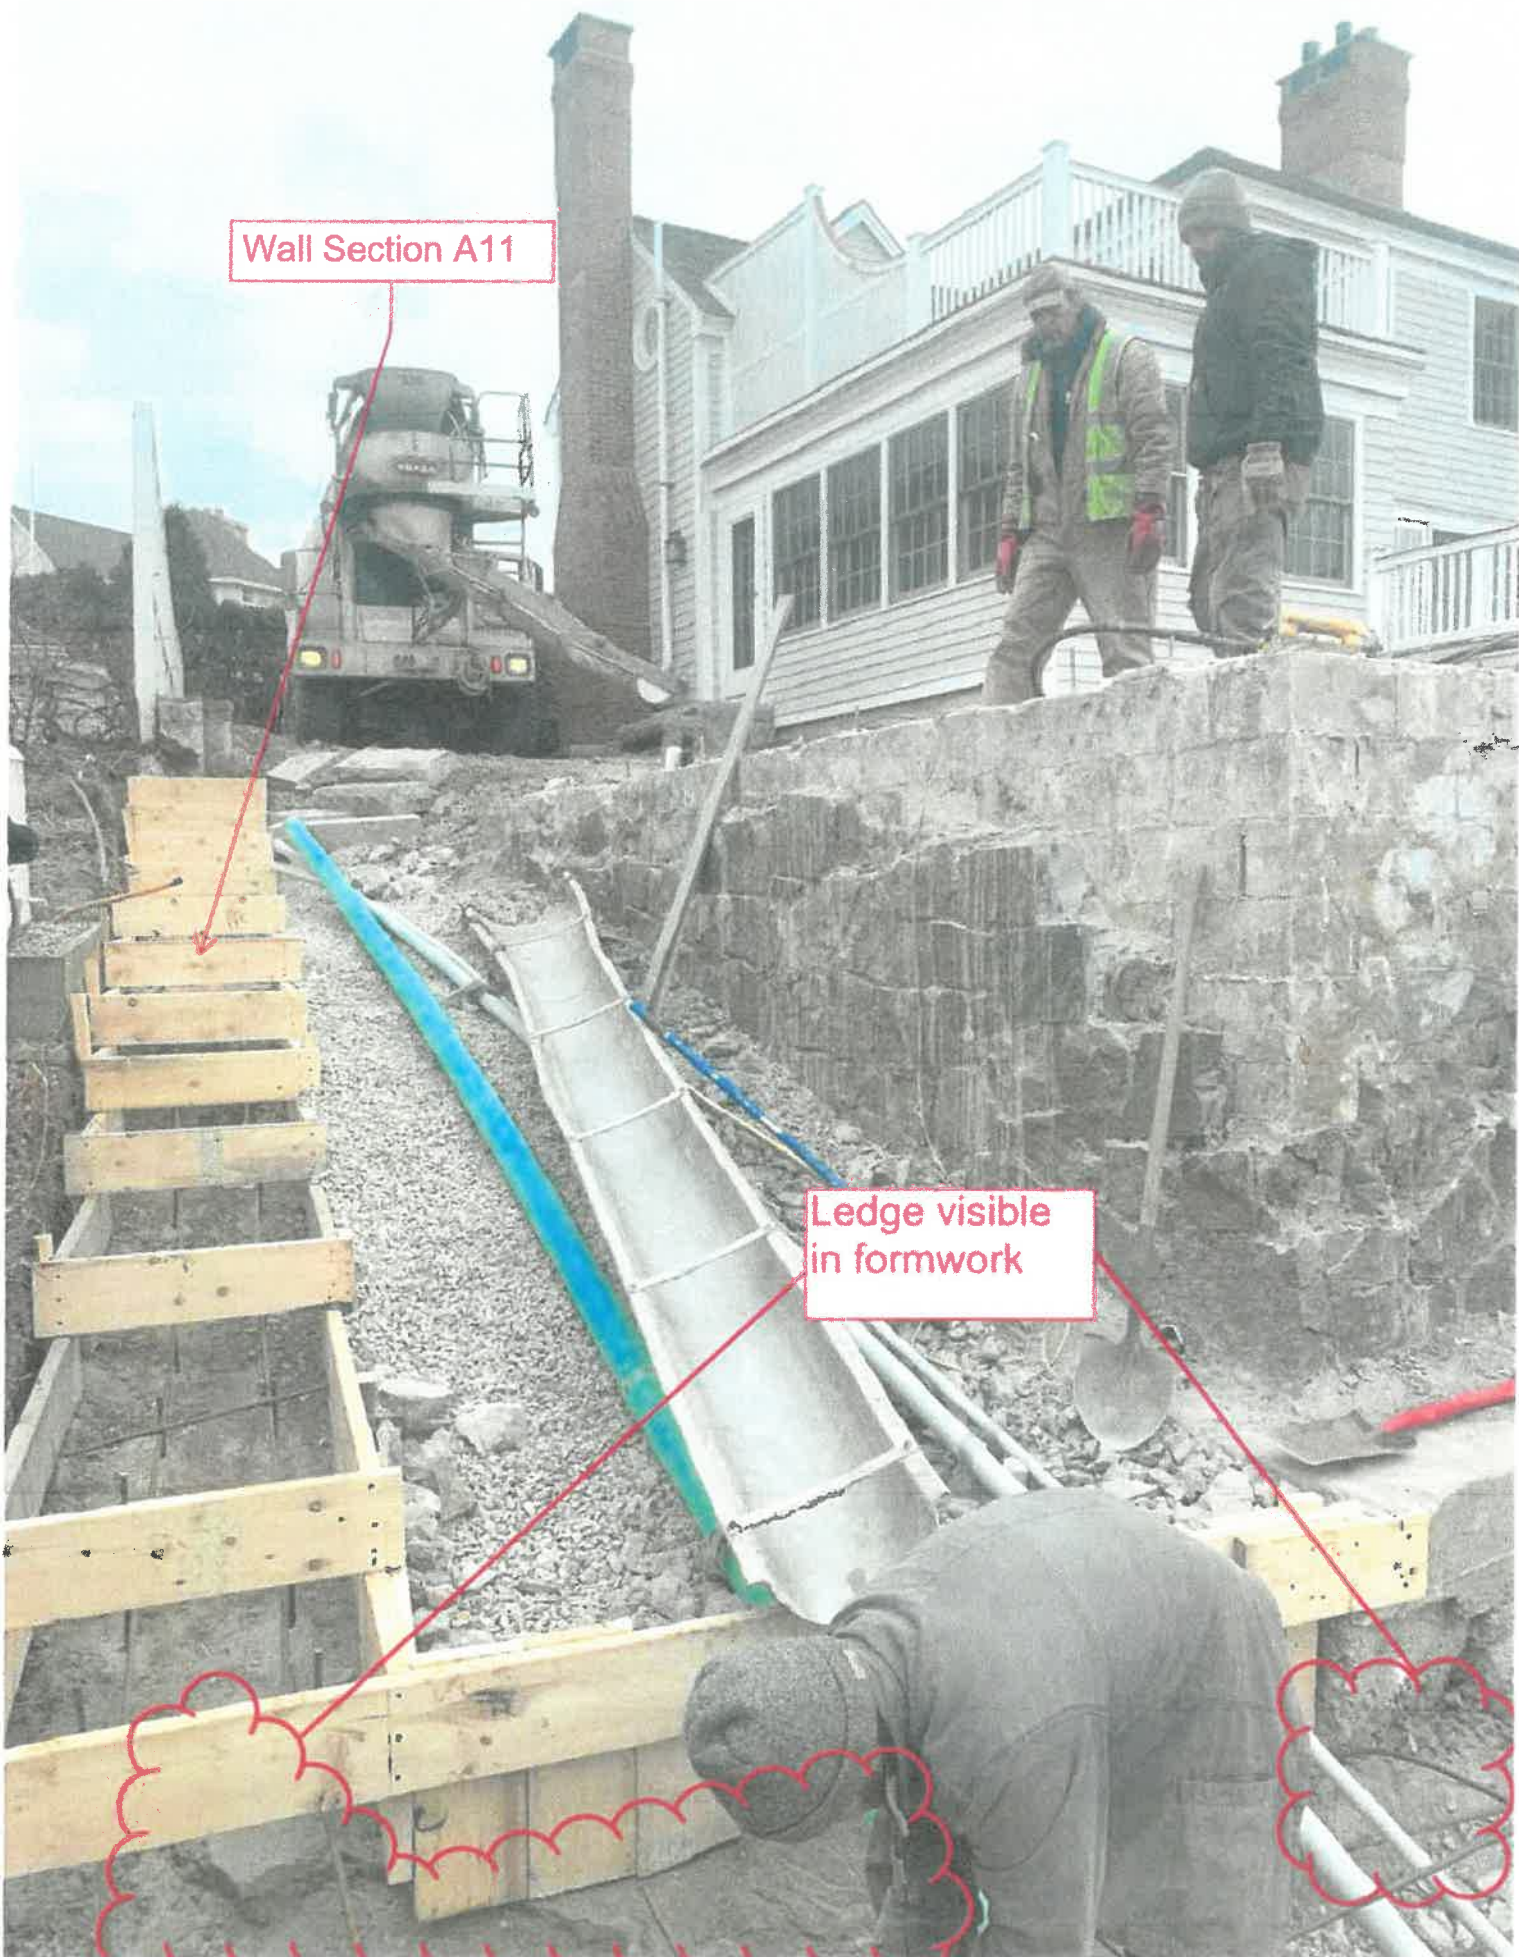
Wall Section A11

Ledge visible
in formwork

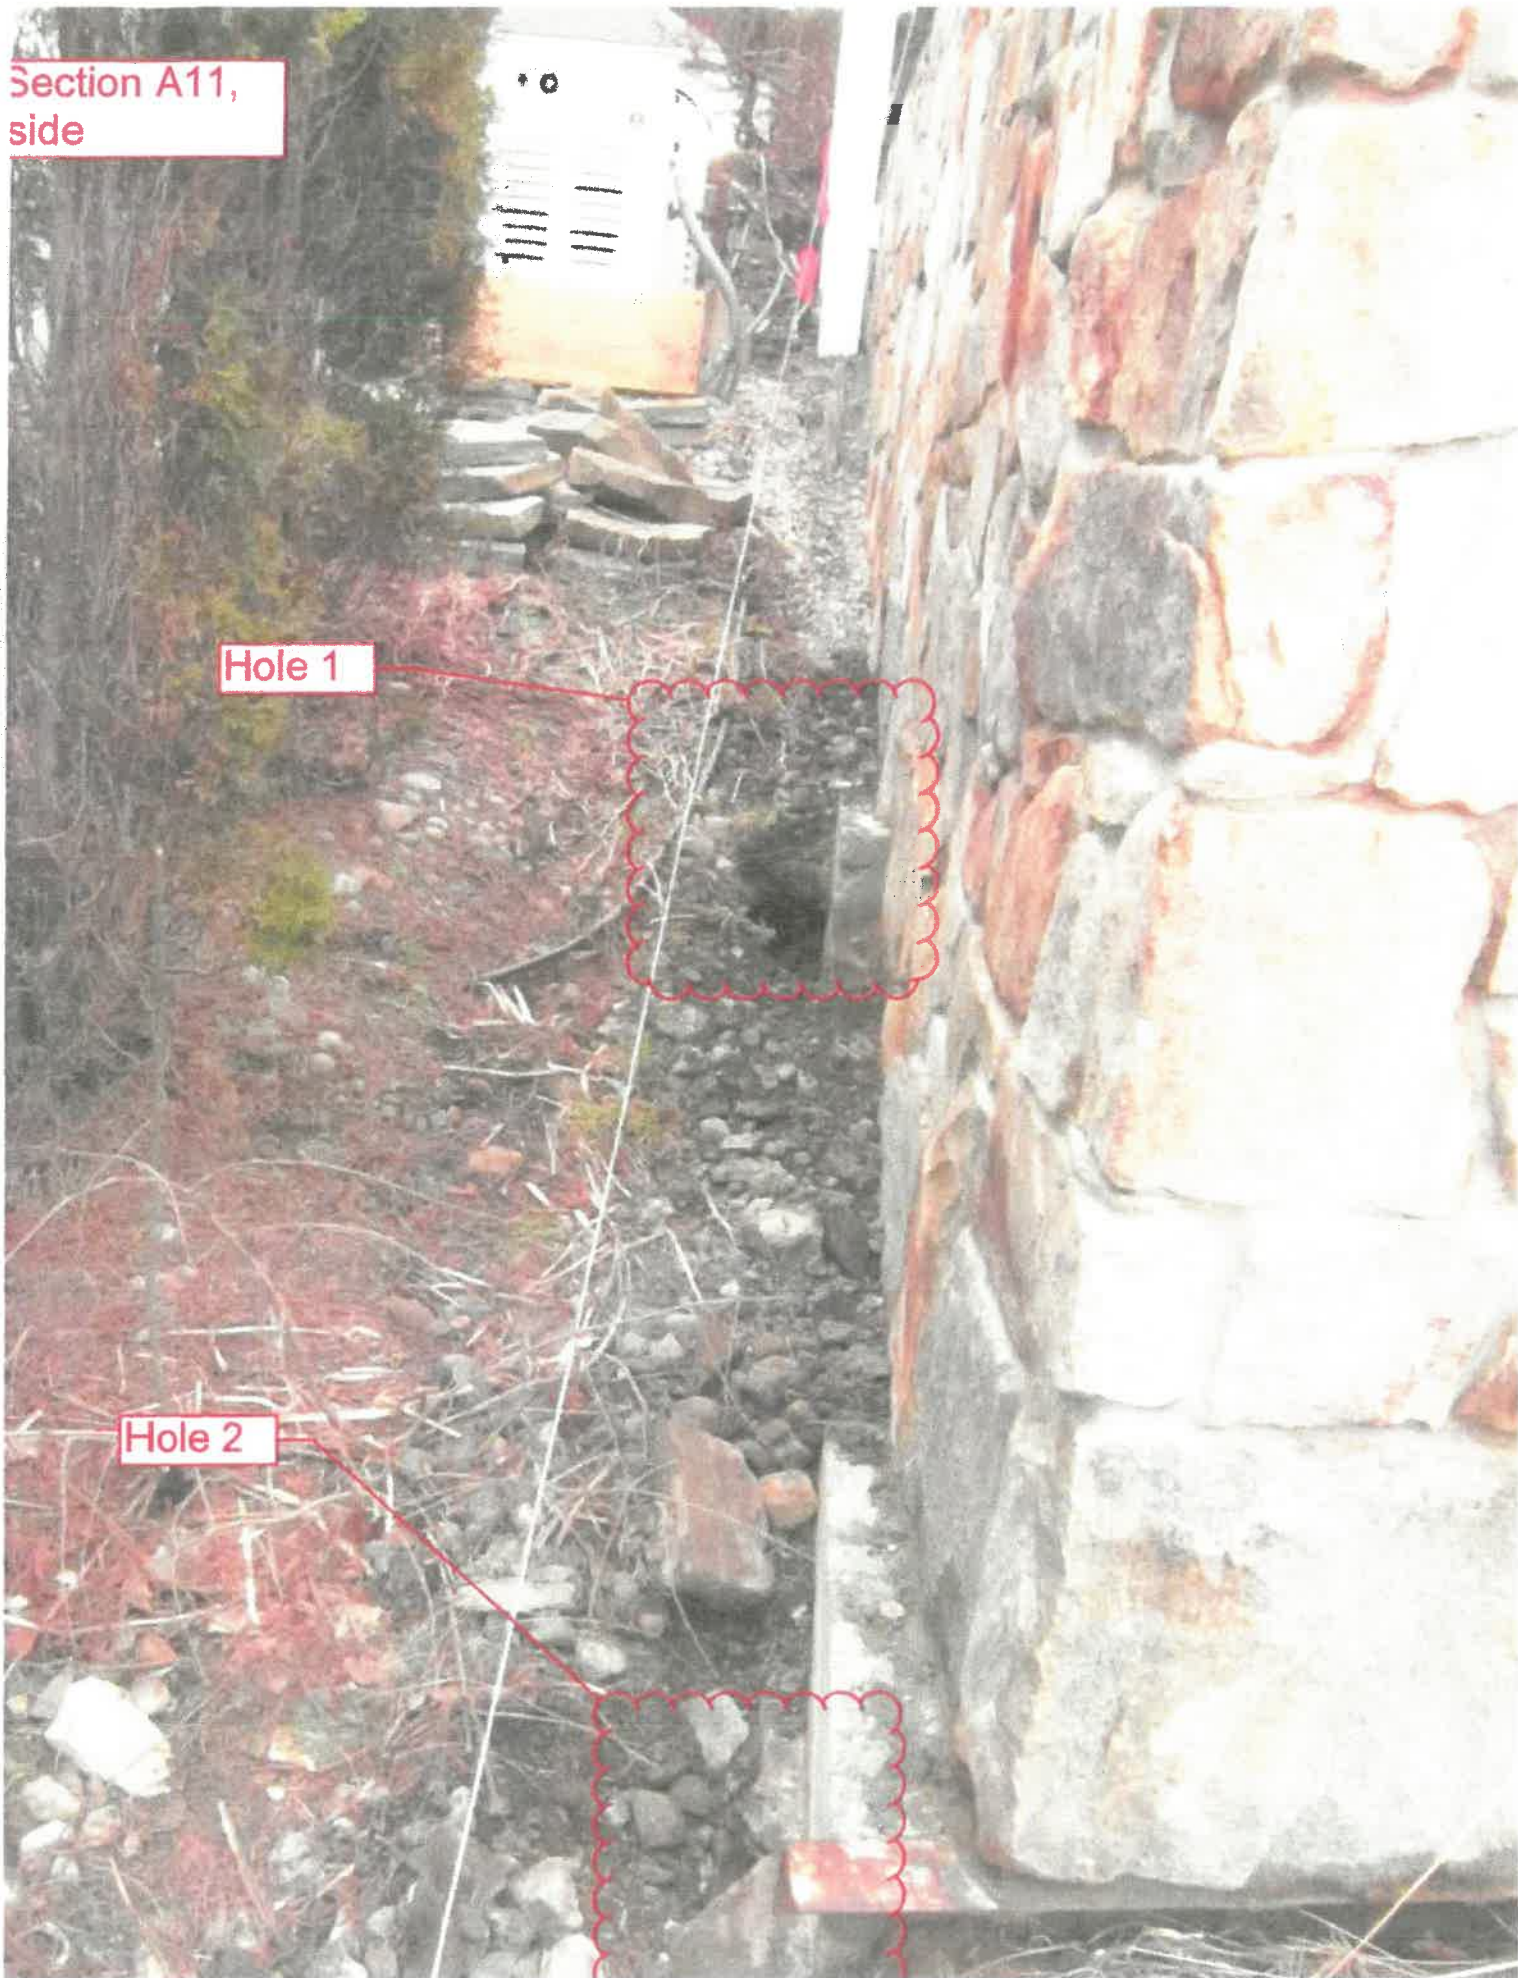
Wall Section A11,
west side, Hole 1

Ledge

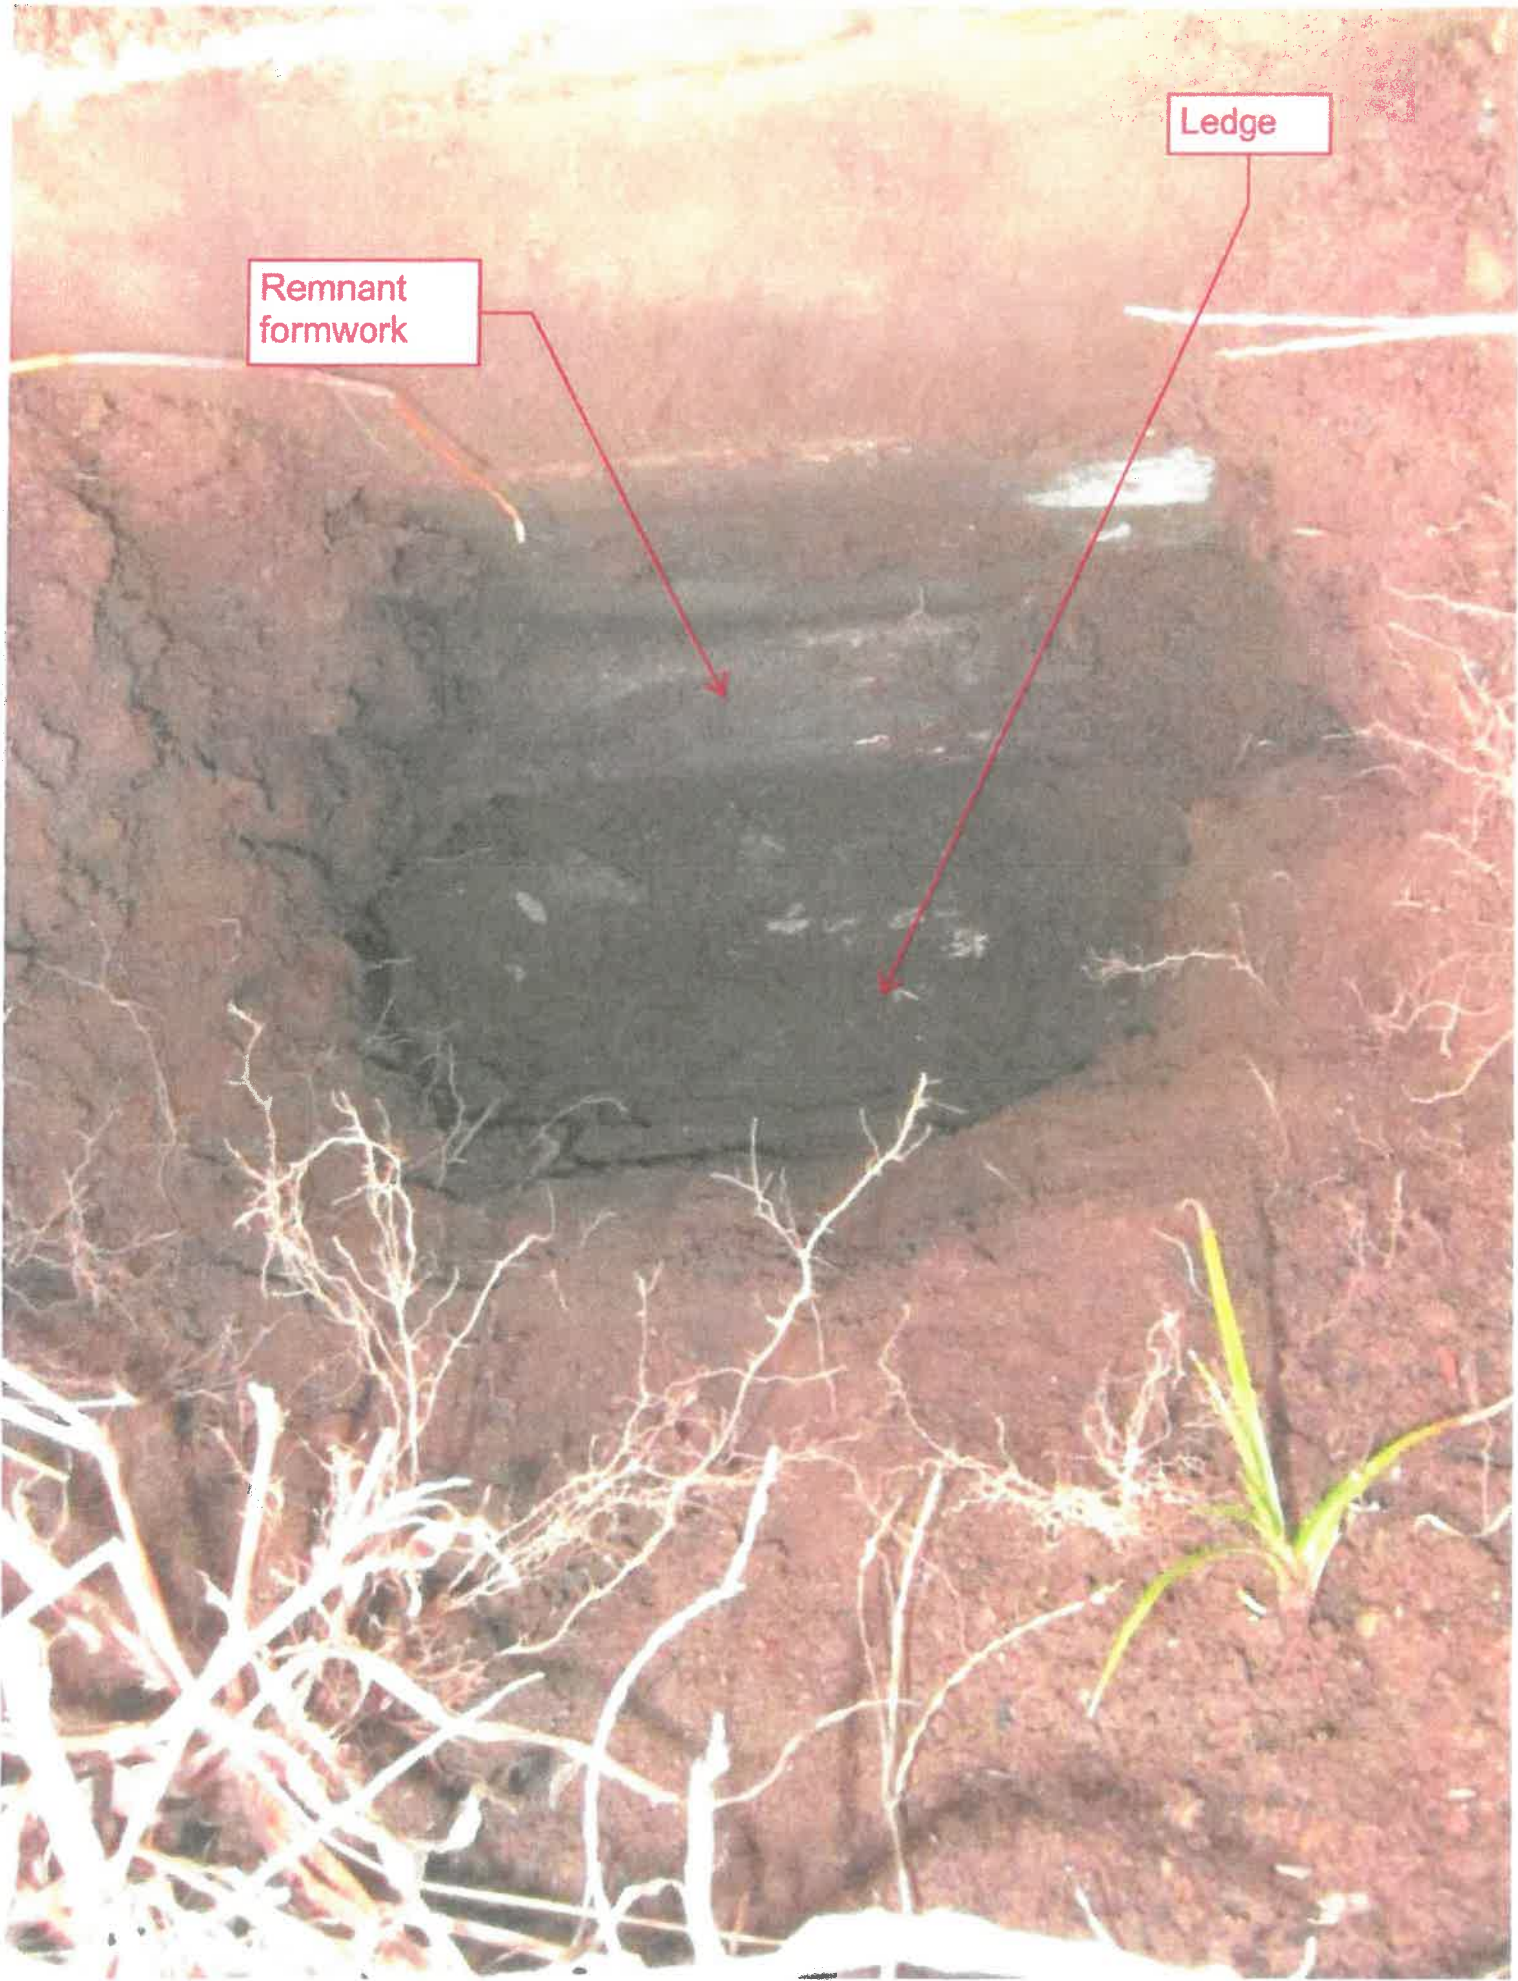
Wall Section A11,
south side, Hole 3

Remnant
formwork

Ledge
