KENNEBUNKPORT ZONING BOARD OF APPEALS
Administrative Appeal Application

Reason for Appeal: Lifting of Suspension of Permits without all corrective measures ordered being taken:

- (1) Resubmitted plot plan does not show demonstrate no increase in lot coverage. (2) Wall section A11 not built per submitted plans, and not to code. (3) Construction of rock walls A2 and A1 appears haphazard, and not to code.
(4) Unauthorized and unlawful work, including patio structure must be corrected. See Addendum for details as to 1-4.

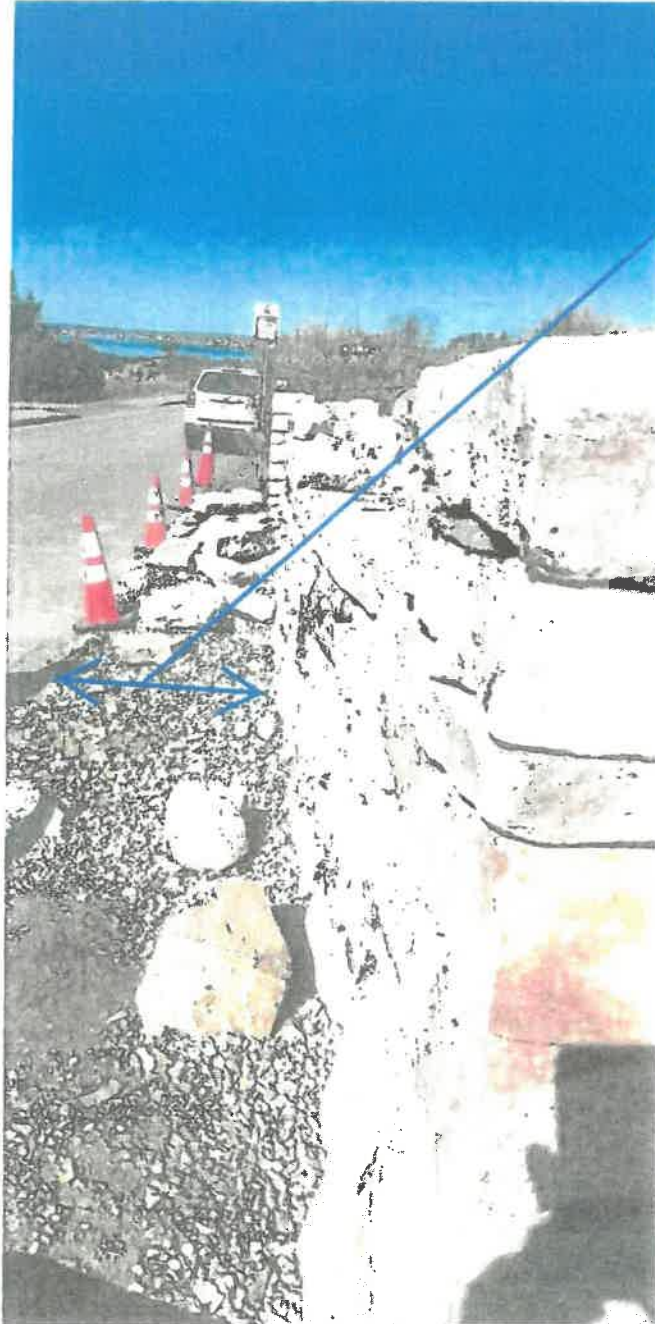
Page 2 of 6 from 4/3/19 SICEI report.
Comments / deficiencies noted in **red** are from SICEI.
Comments in blue are from Price Structural Engineers, Inc. (PSE)

Distance from edge of road to face of wall A2 appears to be the same as the wall that is currently in place.

The wall that was observed by Structural Integrity is therefore likely the same wall that is currently in place.

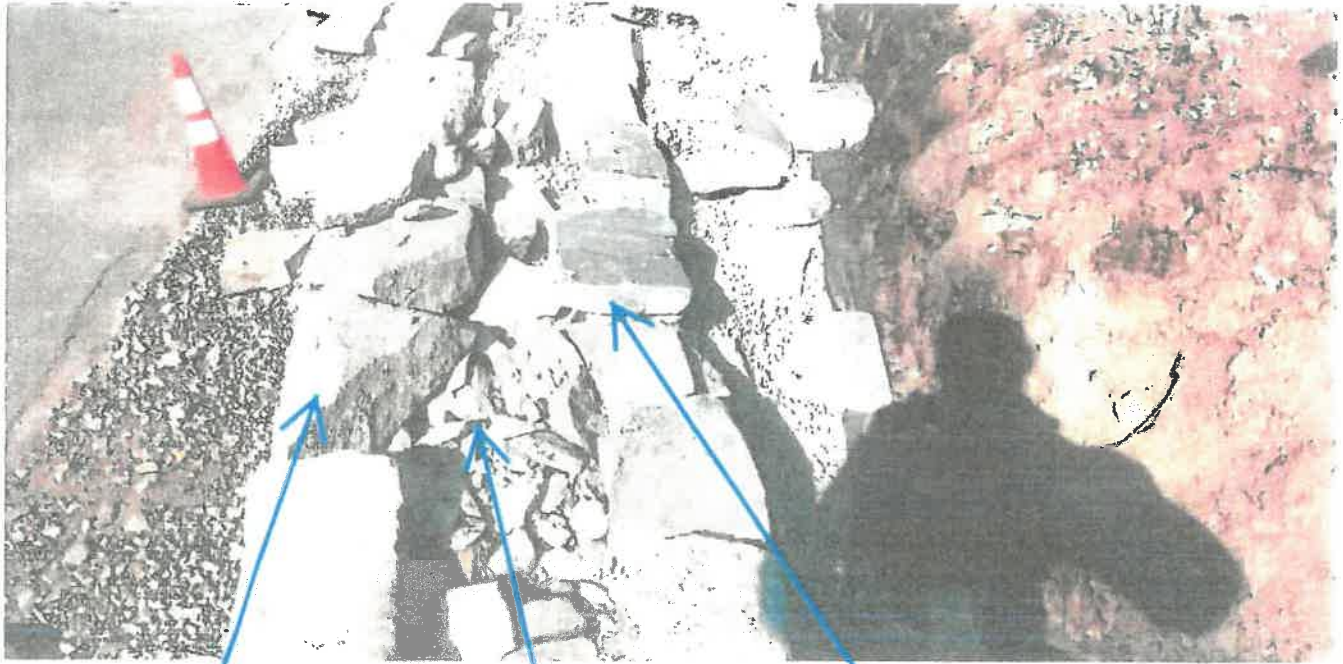
Loose Stones
at Front Wall

Appears to be
broken chips of
stone, crushed stone,
gravel and dirt at
wide space between
front and back walls

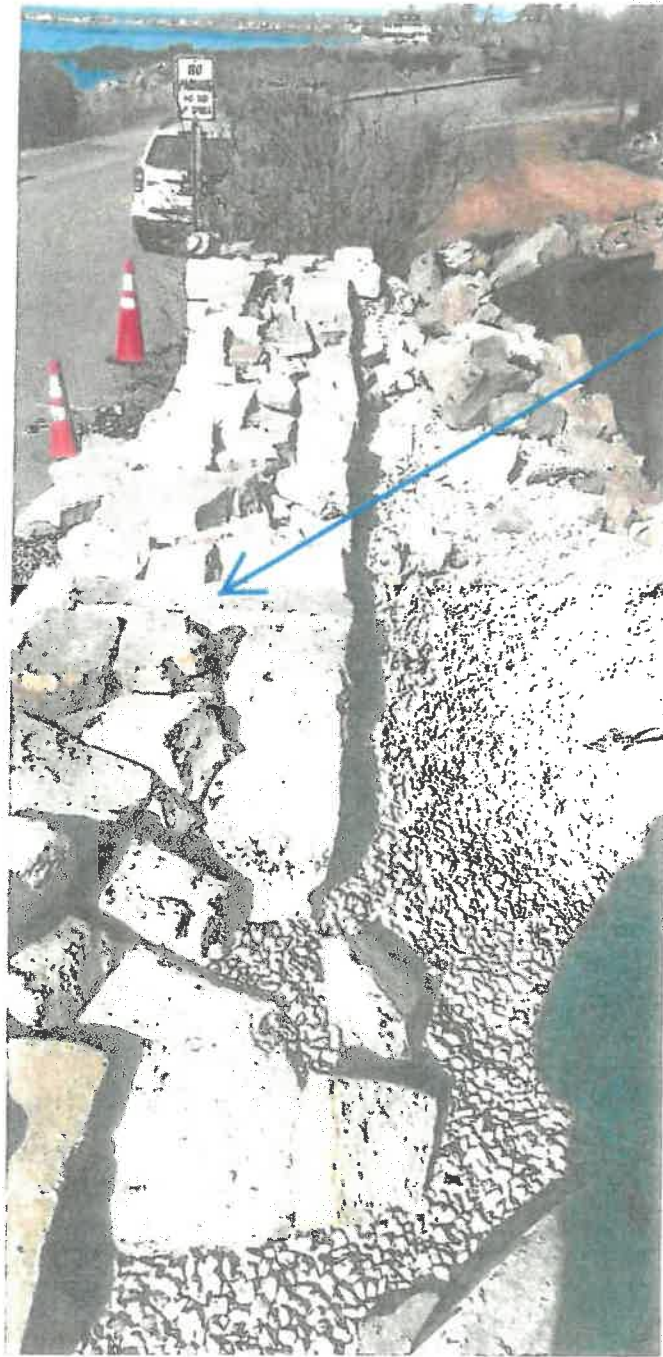
Only one "Through-Stone"
observed in Wall A2.

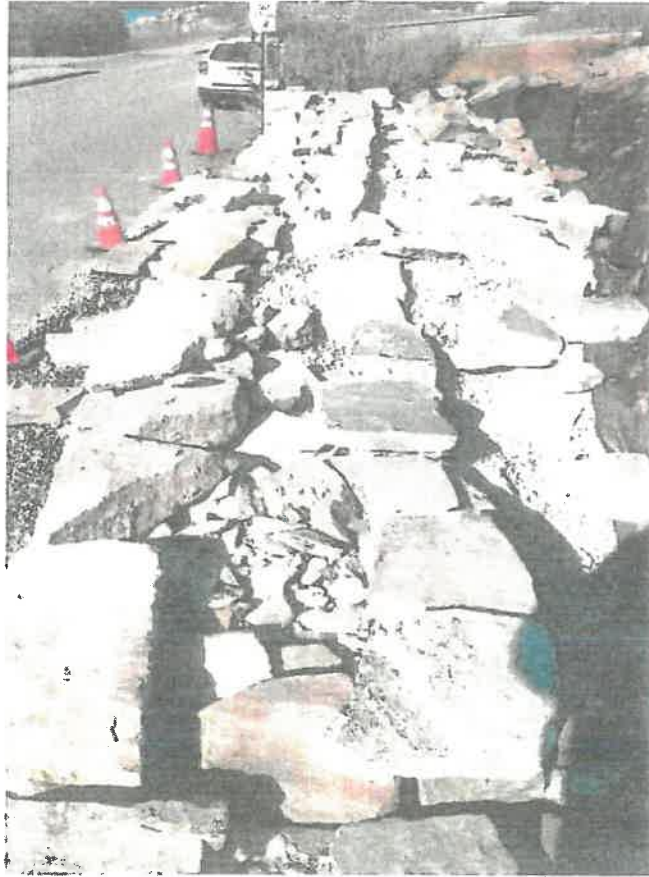
No Through-Stones or
Bonder Units
observed in this photo
