KENNEBUNKPORT ZONING BOARD OF APPEALS
Administrative Appeal Application

Reason for Appeal: Lifting of Suspension of Permits without all corrective measures ordered being taken:

- (1) Resubmitted plot plan does not show demonstrate no increase in lot coverage. (2) Wall section A11 not built per submitted plans, and not to code. (3) Construction of rock walls A2 and A1 appears haphazard, and not to code.
(4) Unauthorized and unlawful work, including patio structure must be corrected. See Addendum for details as to 1-4.

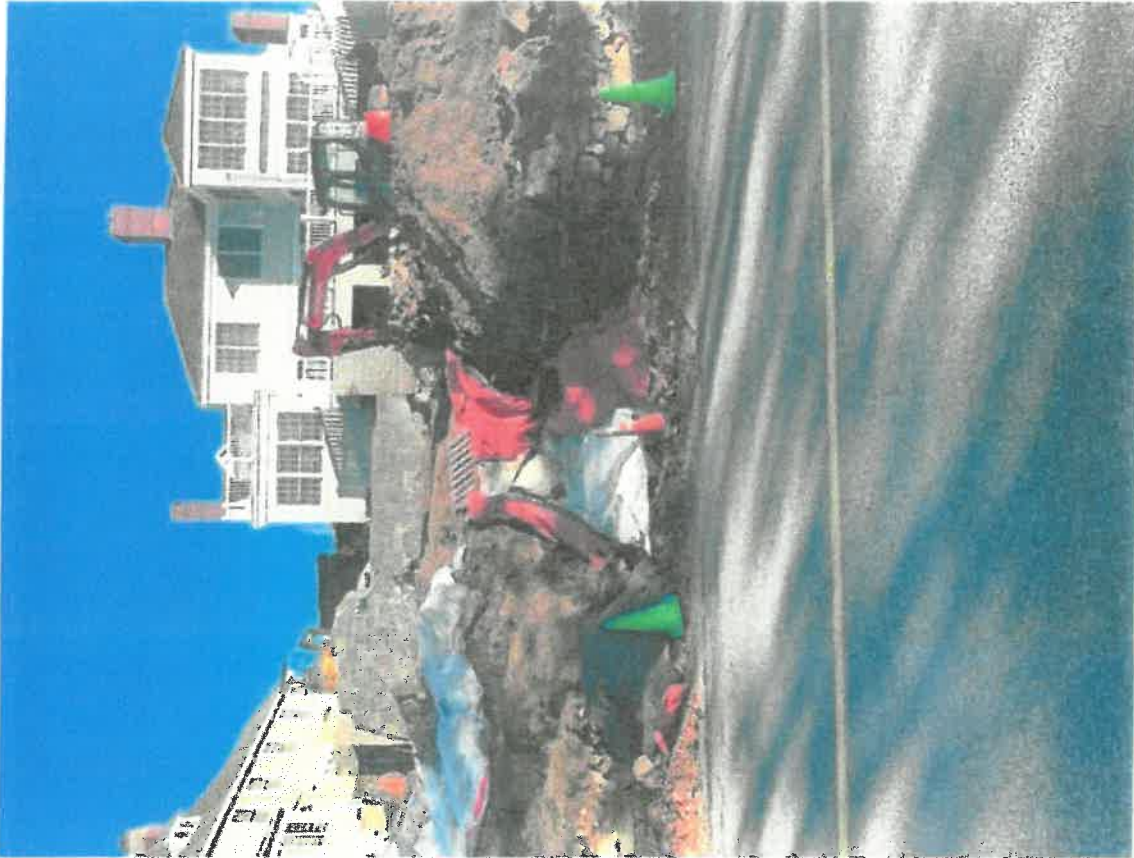
Existing stairs to Ocean Ave were removed and base was excavated for new footing. New stair system construction will begin next week. Existing wall between level 1 from level 2 has been removed. New wall adjacent to lawn has been measured out and the grades have been established for masons to start on wall next week.

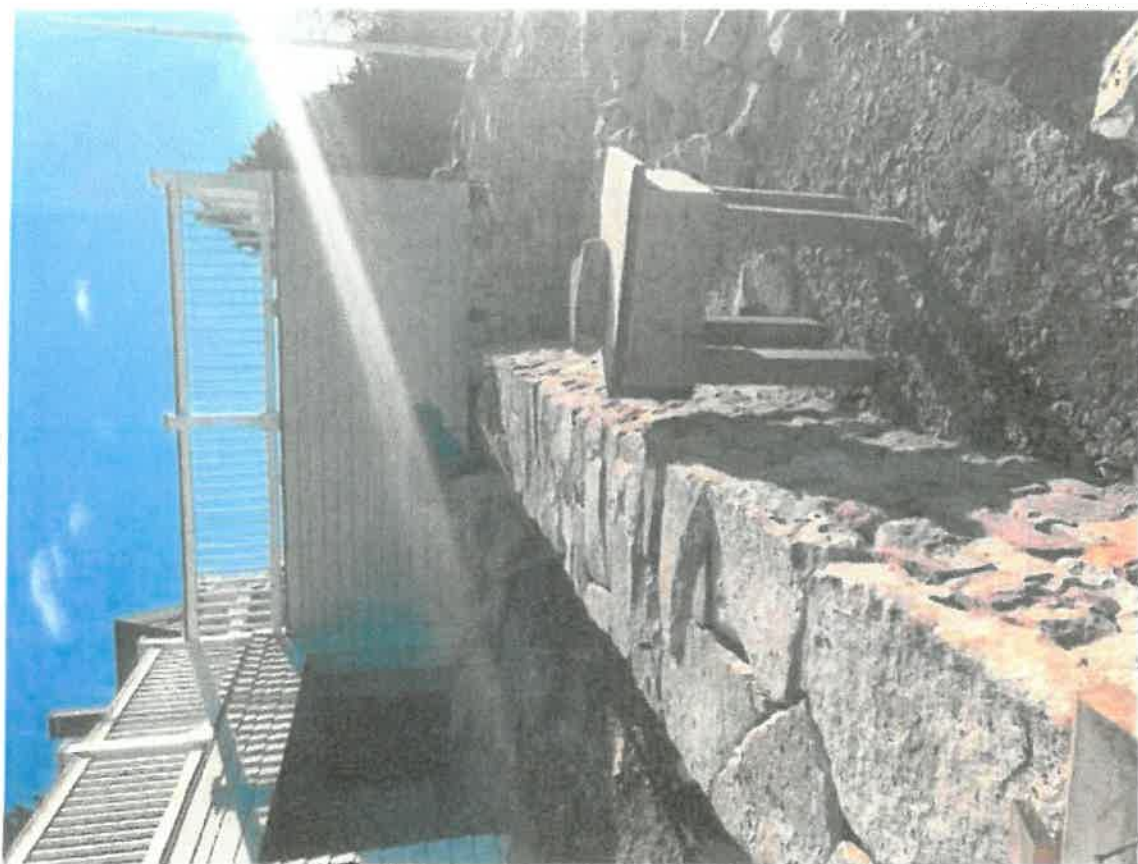
Top of planter wall. To the left will be low shrub planting. To the right will be lawn.

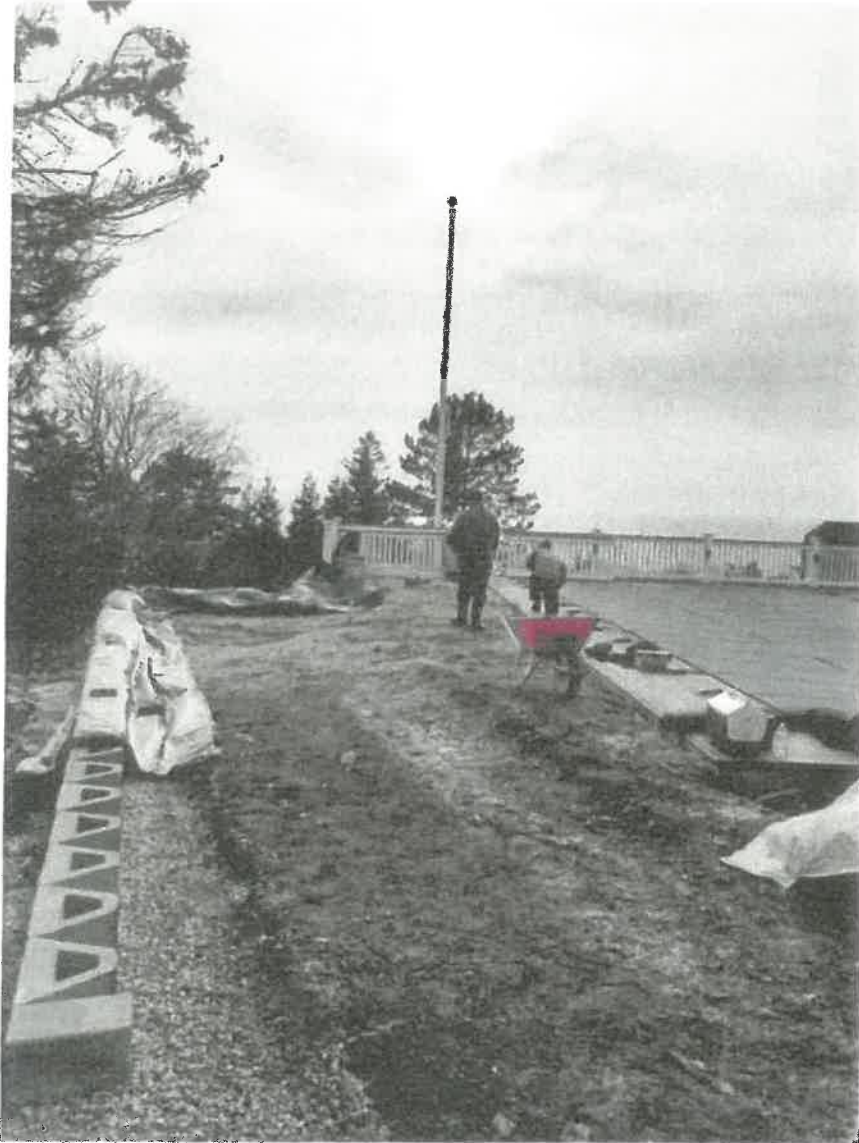
New block wall installed along property line to gain more valuable poolside terrace space. Granite poolside terrace to be installed between wall and pool deck.

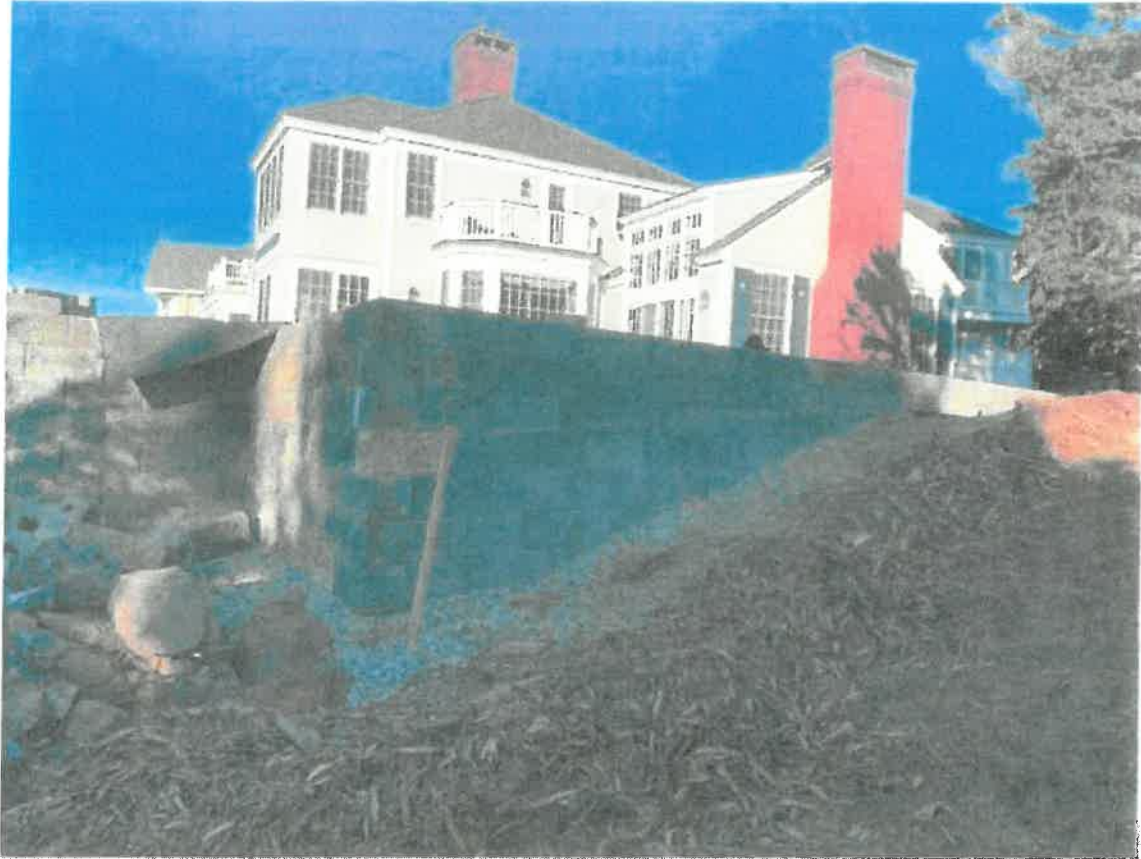
View from neighbor property. New block wall installed to gain more valuable poolside terrace space above.

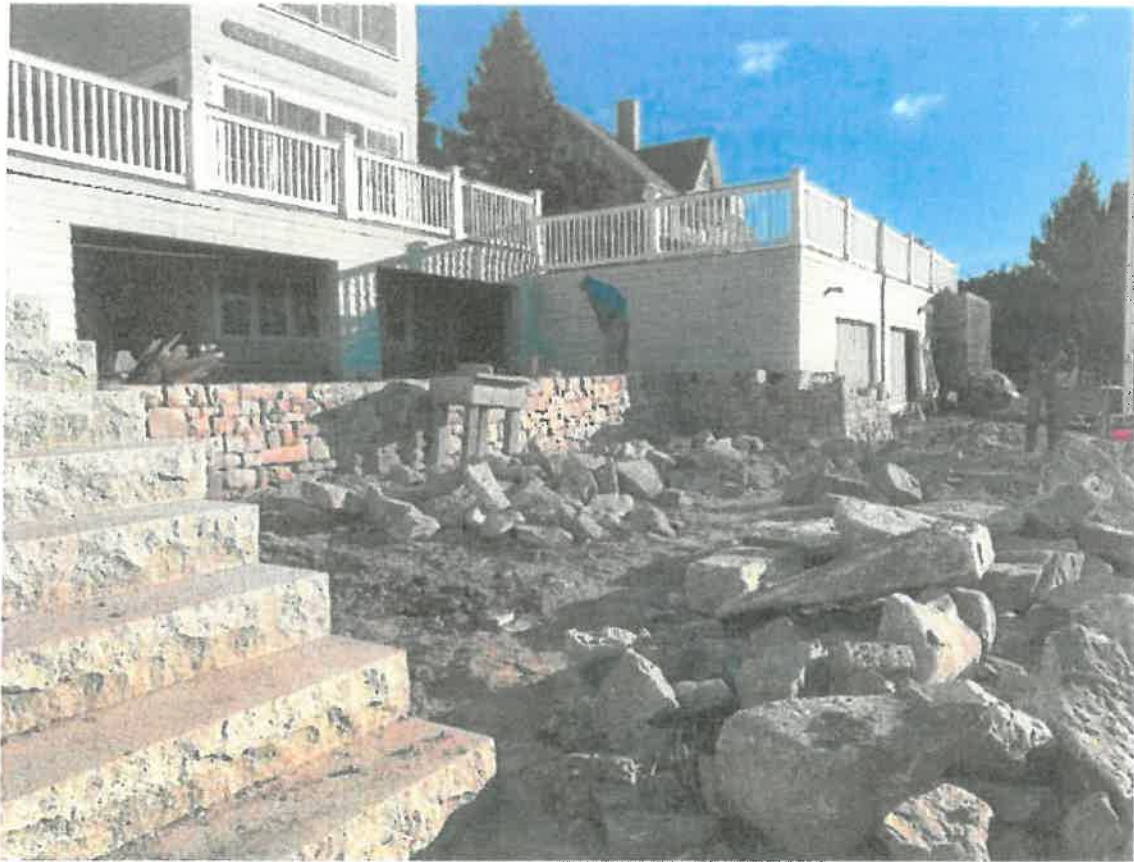
Further progress on planter wall/stone skirting. To be finished today.

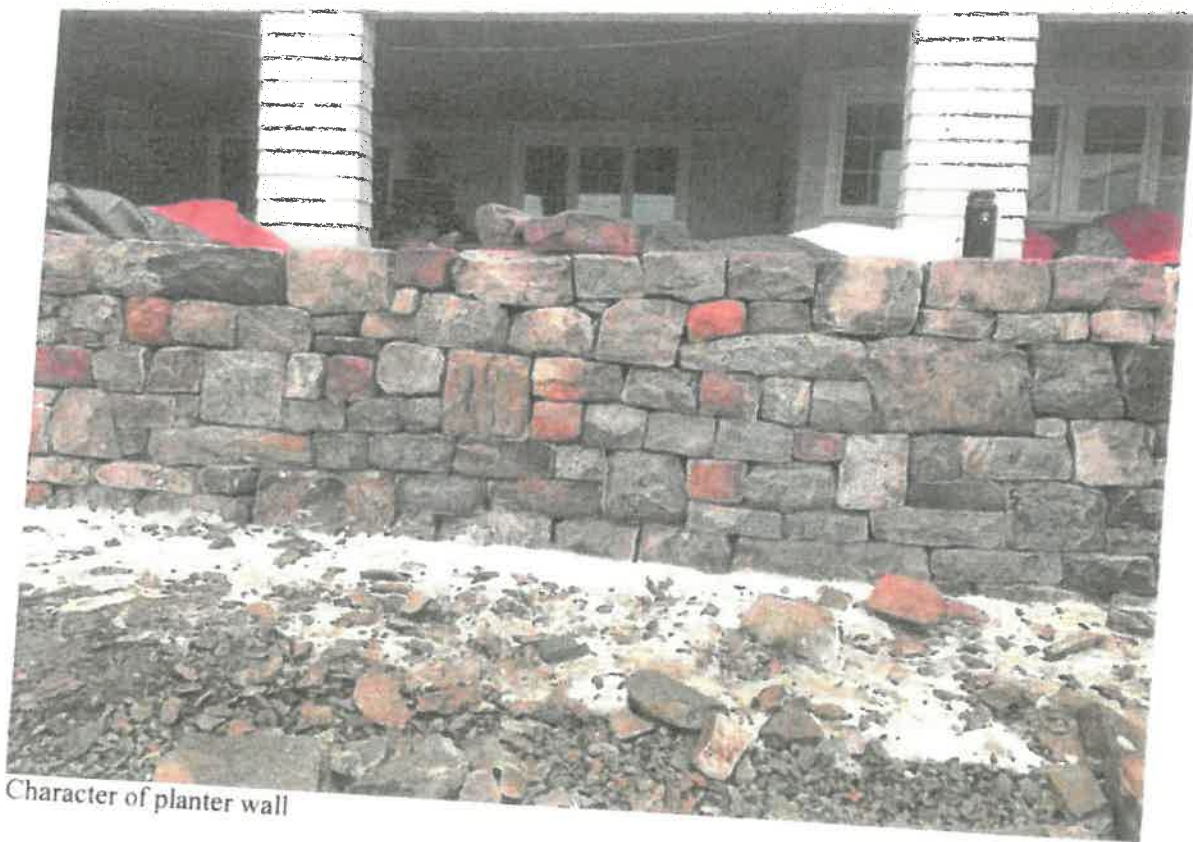
Character of planter wall

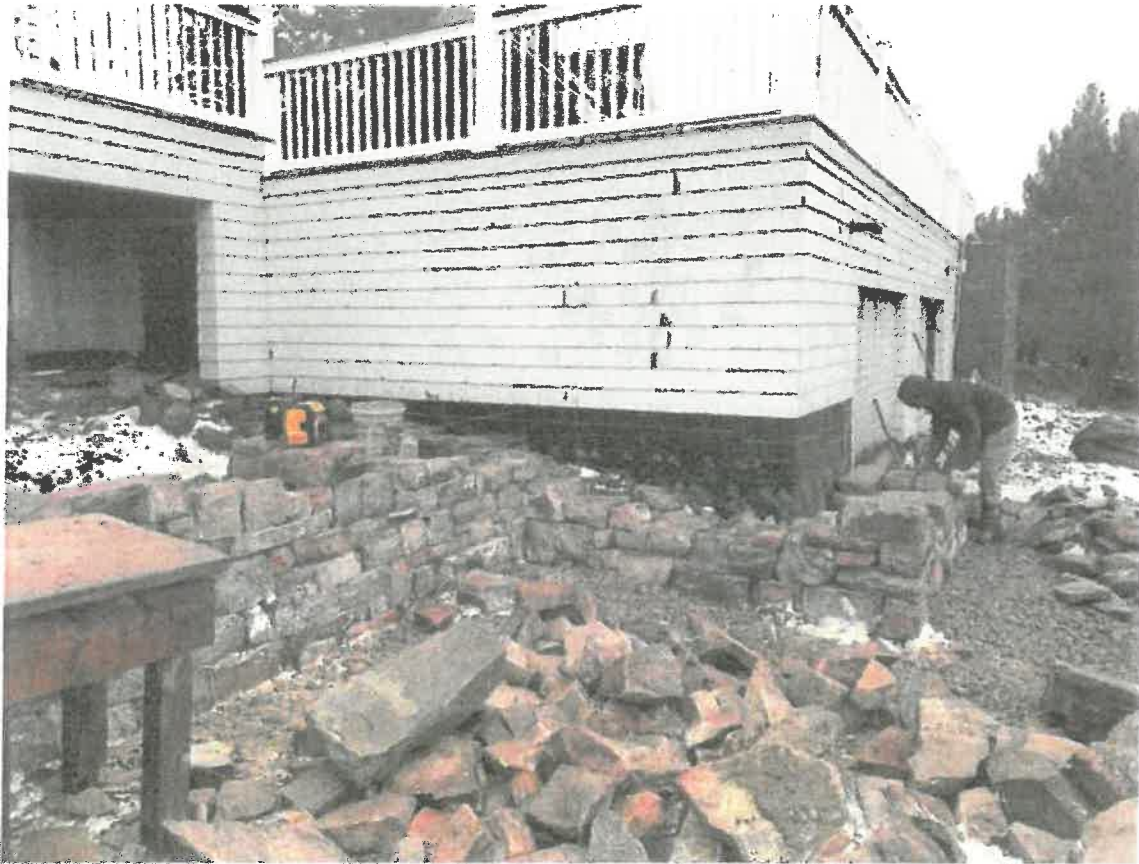
Planter wall/stone skirting in progress. Shingle rot removed and black bituthene water shield installed.

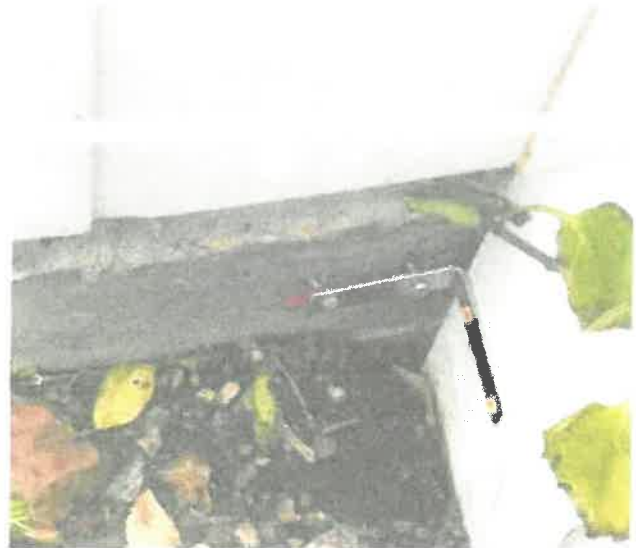
Dislodged fasteners at white fence post

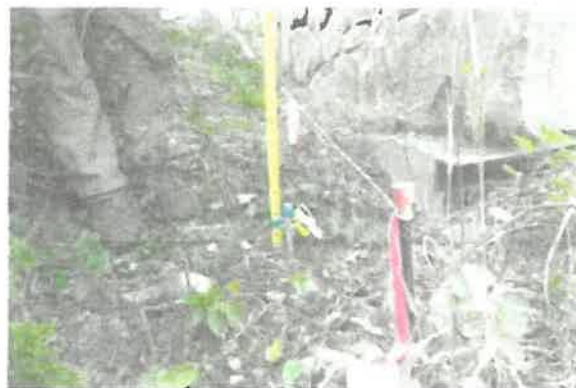
Probe #	Probe Length	Depth Below Ground	Estimate Depth Below Bottom of Footing	Location of Ledge
#1	34"	29"	27"	Not Found
#2	62"	33"	23"	Not Found

Photo #2 – Probe #1 after embedment

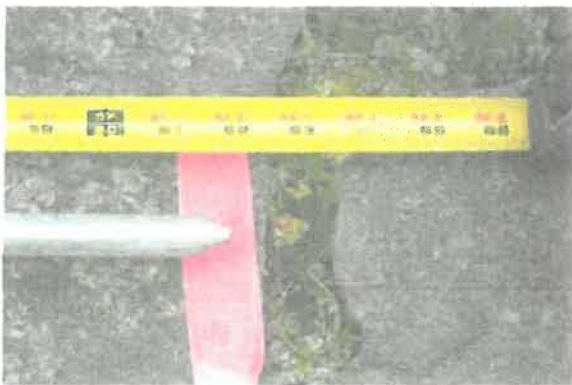
Photo #4 – Probe #2, note pointed tip

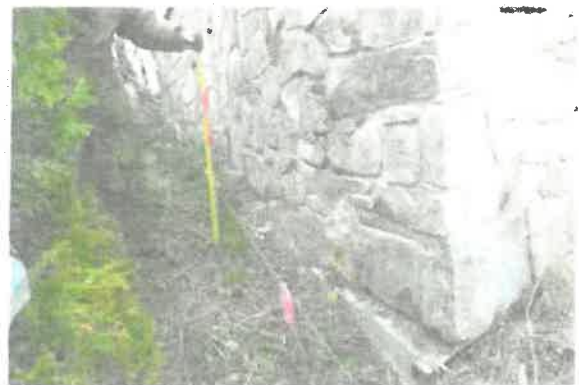
Photo #6 – Probe #2 at 5' north of corner

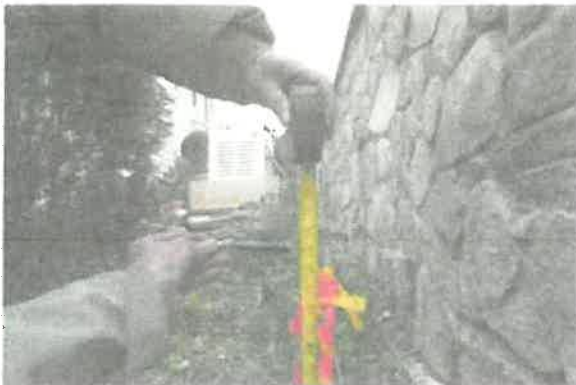
Photo #7 – Probe #2 at 29" above grade

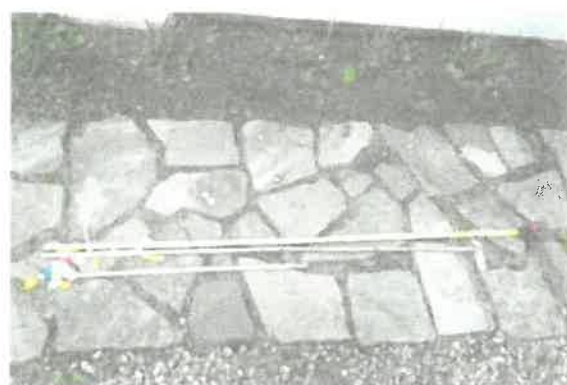
Photo #8 – Probes #1 & #2 after extraction

Some attention is given in the Price report to the speculated lack of ledge below the retaining wall. The Price Report notes two test probes which did not find ledge. These probes are of questionable value as they were not below the wall, nor on the same property as the wall. The probes do nothing to confirm the bearing depth or bearing material of the wall. They were clearly not deep enough to find ledge, as numerous reports record the extremely rocky nature of the site. On January 13, 2020 we spoke with Mr. Keegan Geller, the original owner and builder of the home at 200 Ocean Avenue. Mr. Geller indicated that the site had previously been rejected by other potential buyers because of the extensive rock on site. Mr. Geller described the site as "rock city". Maine Drilling and Blasting was contracted on October 2, 1985 to blast the rock. The ledge was so prevalent that in addition to creating a hollow for house foundations, water and electrical utility trenches required rock removal. As little ledge as possible was removed to facilitate construction, leaving a very rocky site. Please see the attached photo. Rock is clearly visible in the formwork. Although this photo is also in the Price Report (Photo #12), the Report incorrectly speculates "...it is doubtful that the material directly below the footing is ledge." The photo also clearly shows rebar dowels in the upper sections of formwork, although the resolution of the photo could lead to a misinterpretation of the soils. In construction of foundations on ledge, a thin leveling layer of stone dust, gravel, or other soil is very commonly placed above the rock to facilitate formwork placement and to assure more consistent concrete placement. The thin soil layer does not increase risk of frost heave. Based on the photo, the wall builder's record of drilling dowels into ledge, prevalence of rock at this site, and the performance of the wall, it is difficult to doubt that the wall bears on ledge.

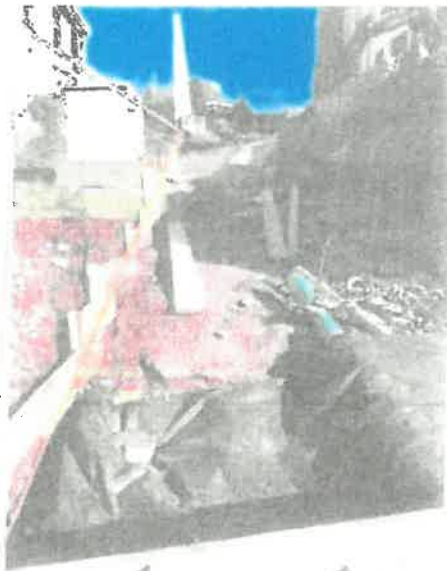
Photo #11 (by others) – View looking north. Photo and caption above from Joshua Tomkins on 1/15/19 at Wall A-11. Soil added up to bottom of forms. No ledge is observed or referenced in the caption. No soil compactors observed in photo. Plastic sheeting or filter fabric added. No ledge observed for securing steel pins into ledge under footing as reported. Note generator at upper left of photo.

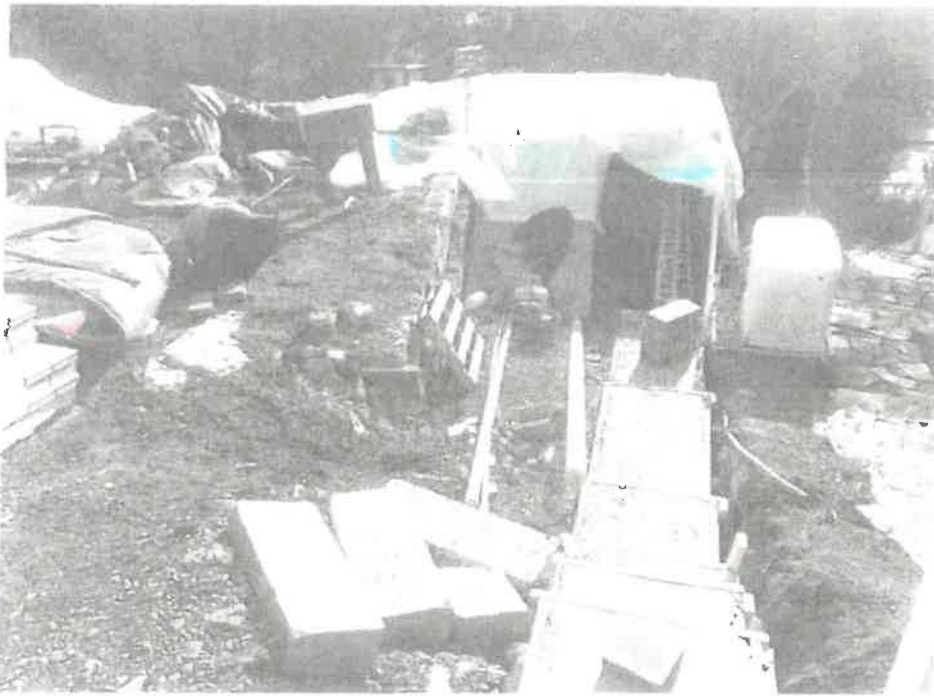
Photo #13 (by others) – Appears to be view looking south (generator on right, drain pipe on left) at stepped footing higher up the hill. Note CMU inside covered area beyond. An enlargement of this photo inside the cover is below (see Photo 14).

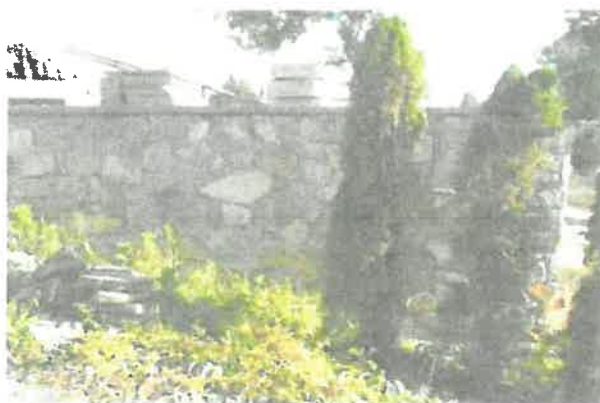
Photo #16 – Level cap at top of CMU wall

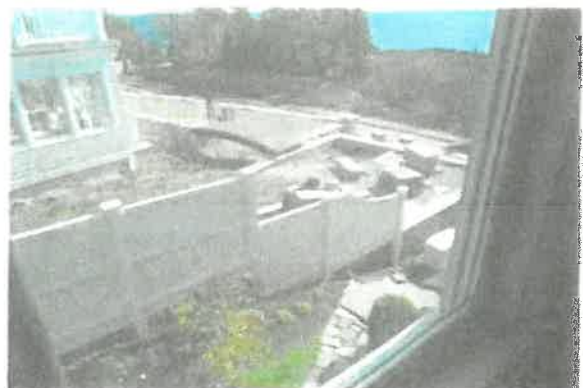
Photo #17 – CMU wall extends north of generator

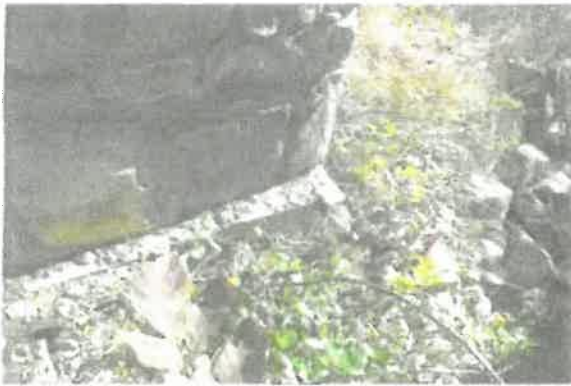
Photo #20 – Fully exposed footing above final grade

- g. If there is no ledge then the CMU footing, the top of which extends above final grade, may be highly vulnerable to frost heave.
- h. If there is no ledge, then an analysis using a conventional retaining wall design procedure (attached) indicates that the masonry wall may be highly unstable.

- Temporally expose the west face of the existing CMU footing down to the bottom of the footing at multiple places selected by PSE (10 places minimum) so that the features of the substrate supporting the existing CMU footings, including the extents of reported ledge, may be observed directly.

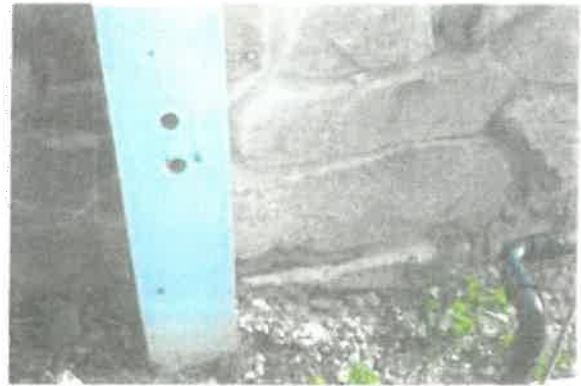
Photo #21 – Exposed footing near fence post

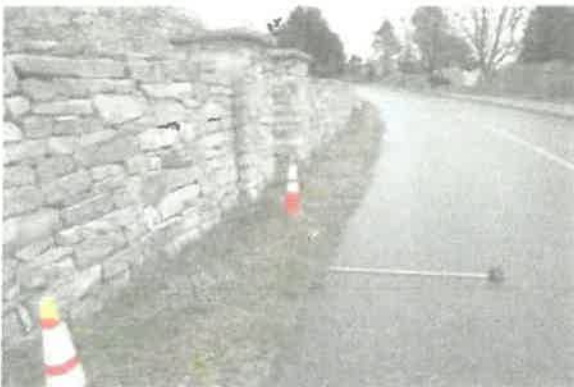
Photo #22 – Estimate wall A-2 distance form road

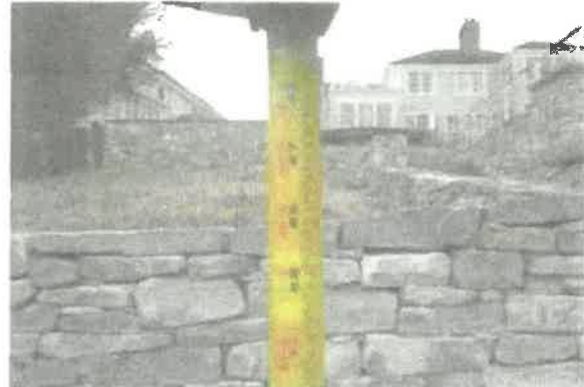
Photo #23 – Wall A-2 appears to be 5'-6" high

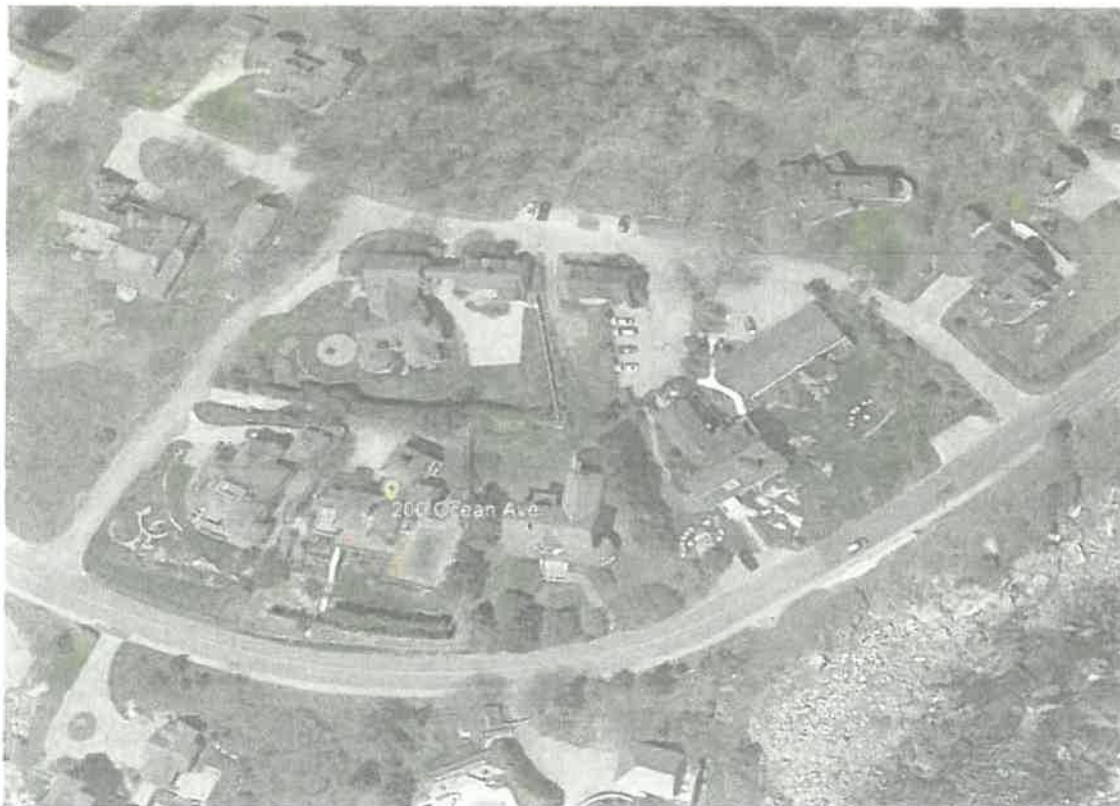
Photo #25 – Blind curve in front of 200 Ocean Avenue (reference: Google Earth)

- d. The A-1 and A-2 rubble stone walls are situated close enough to the existing Ocean Avenue pavement that if an overturning collapse were to occur there is a realistic possibility some of the stones could unexpectedly be in the travel path of vehicles.
- e. The potential for a partial collapse of these walls should be taken seriously due to the significant volume traffic on Ocean Avenue. Furthermore, the walls are located near a relatively blind curve so there would be less reaction time if were stones unexpectedly in the travel path of vehicles (photo #25, page 19).

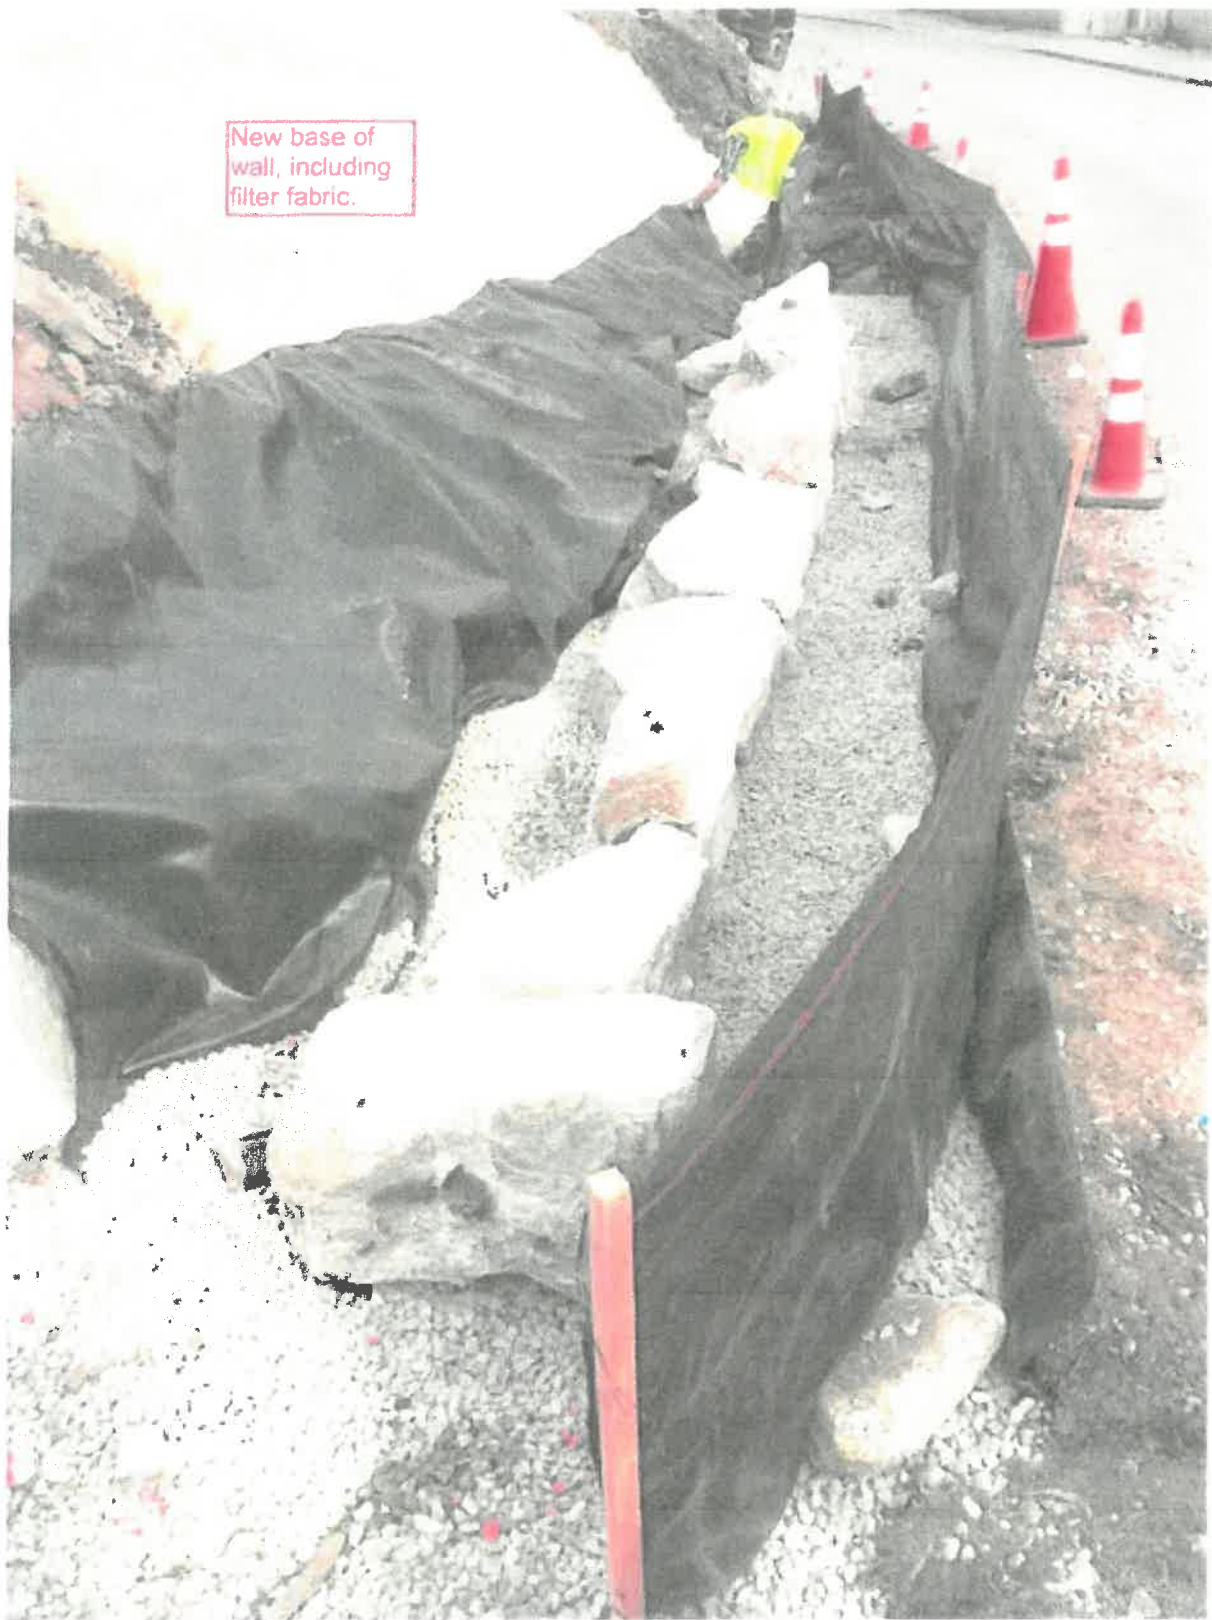
New base of wall, including filter fabric.

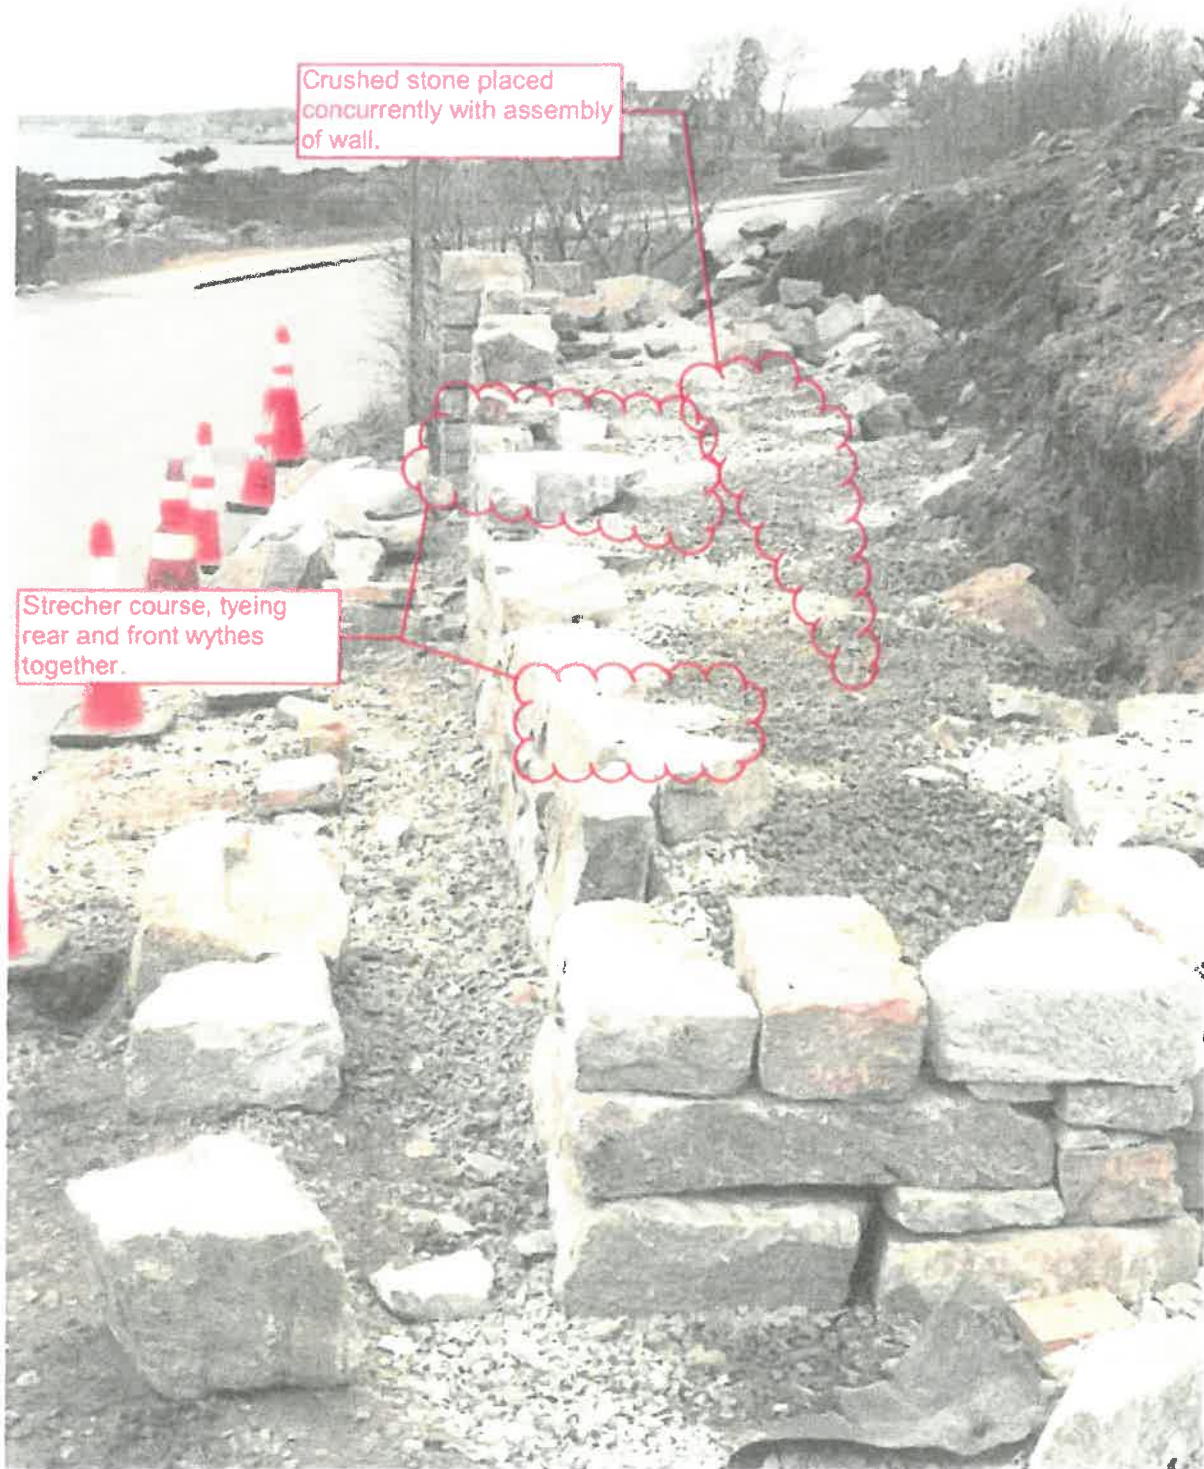
Crushed stone placed concurrently with assembly of wall.

Stretcher course, tying rear and front wythes together.

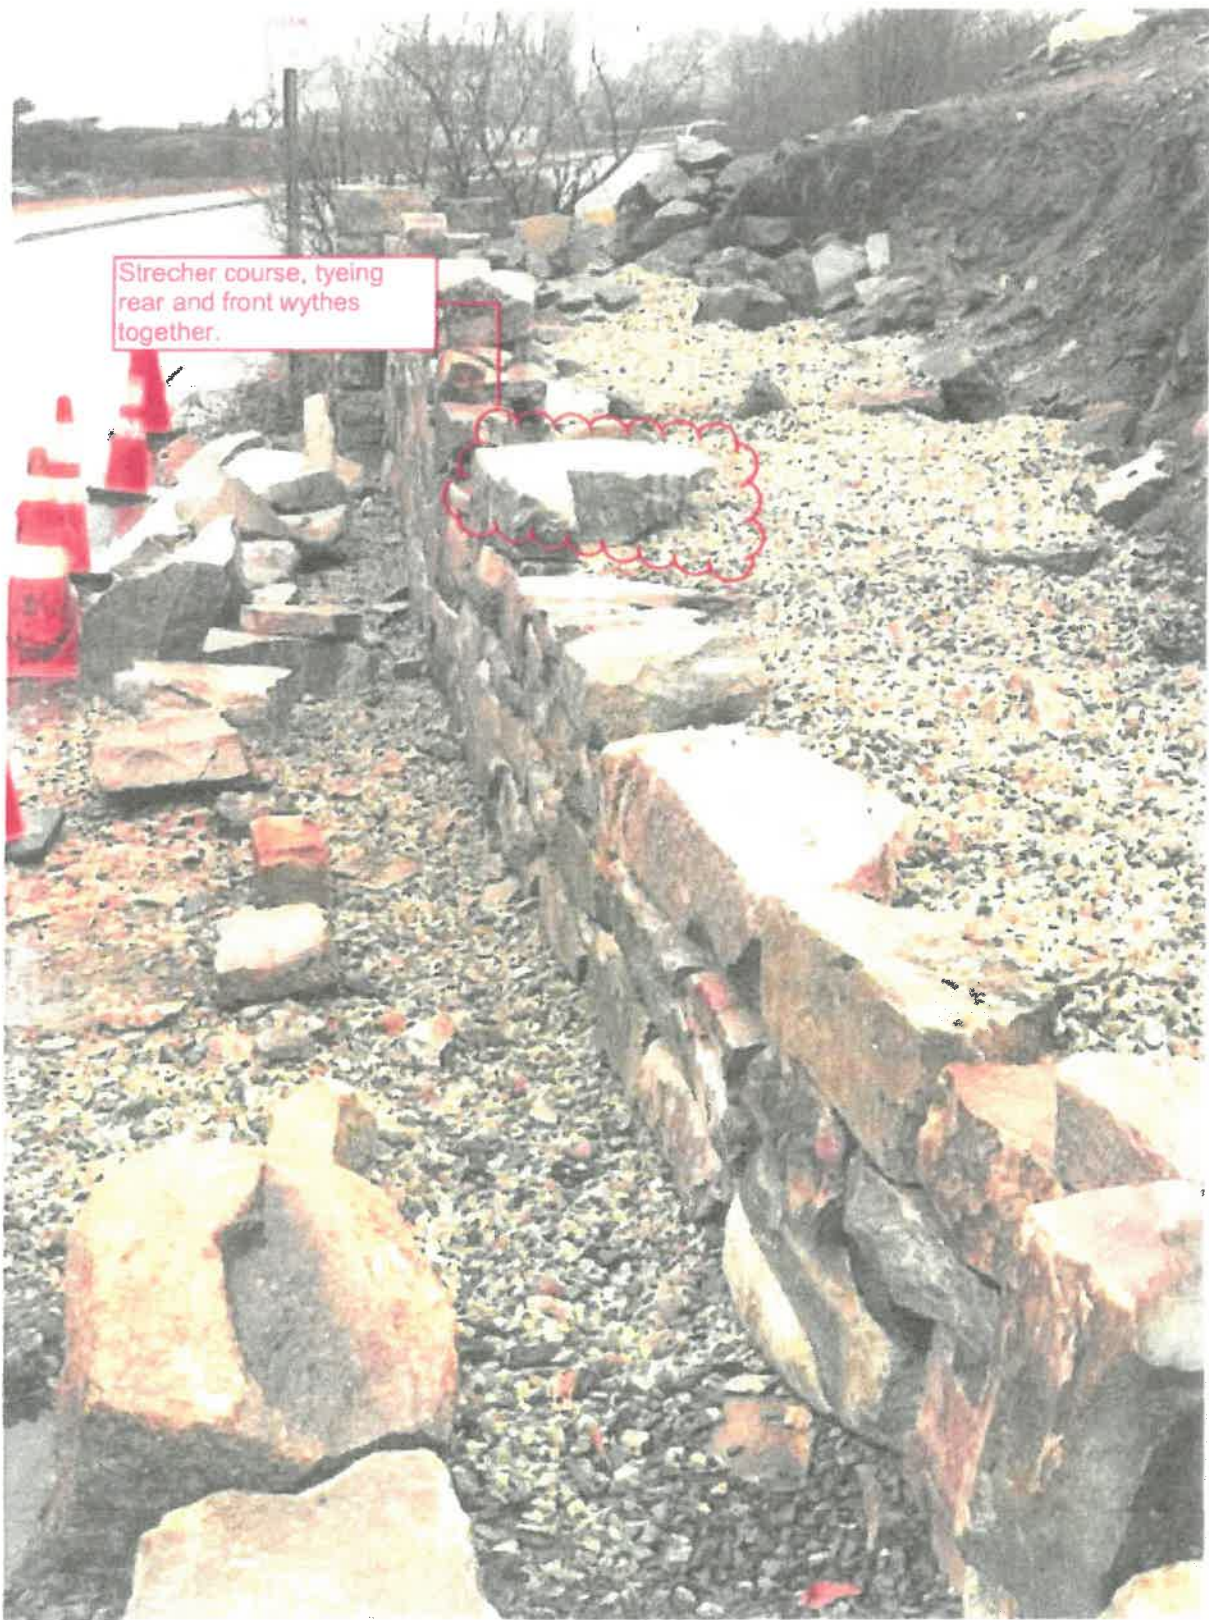
Streicher course, tying rear and front wythes together.

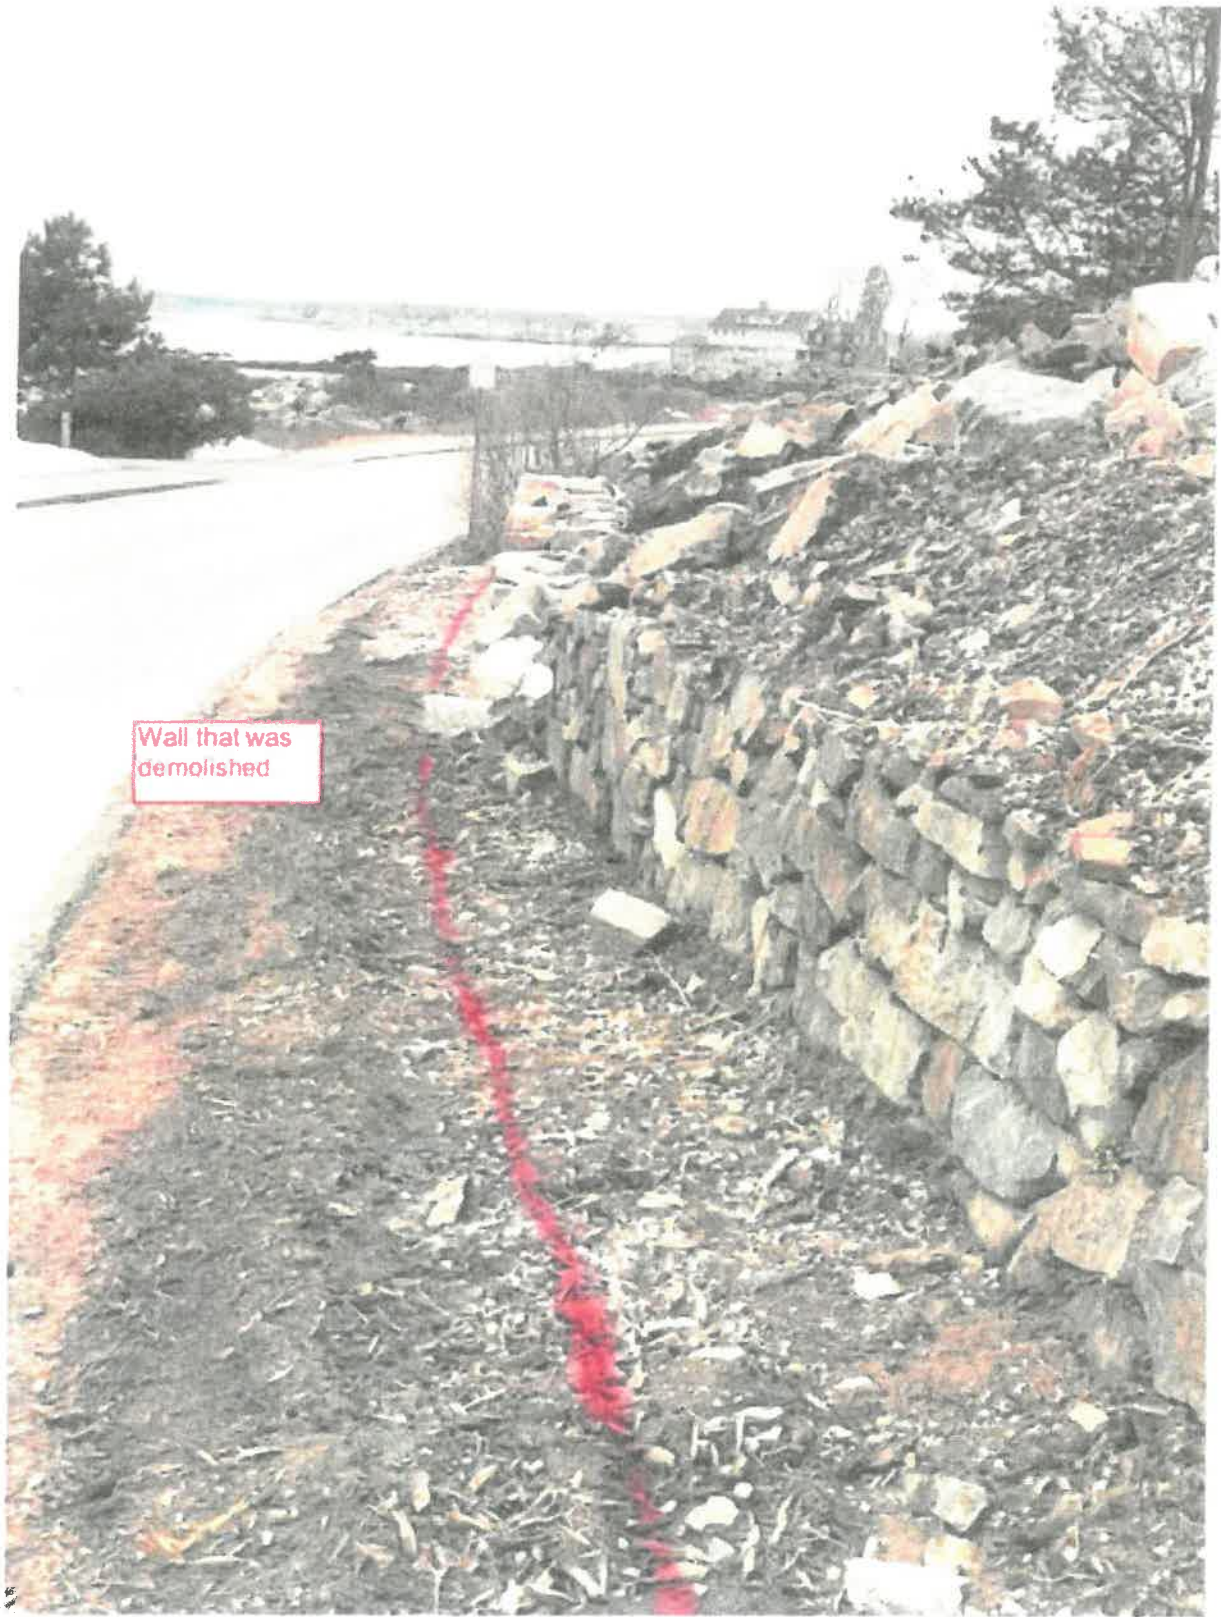
Wall that was
demolished

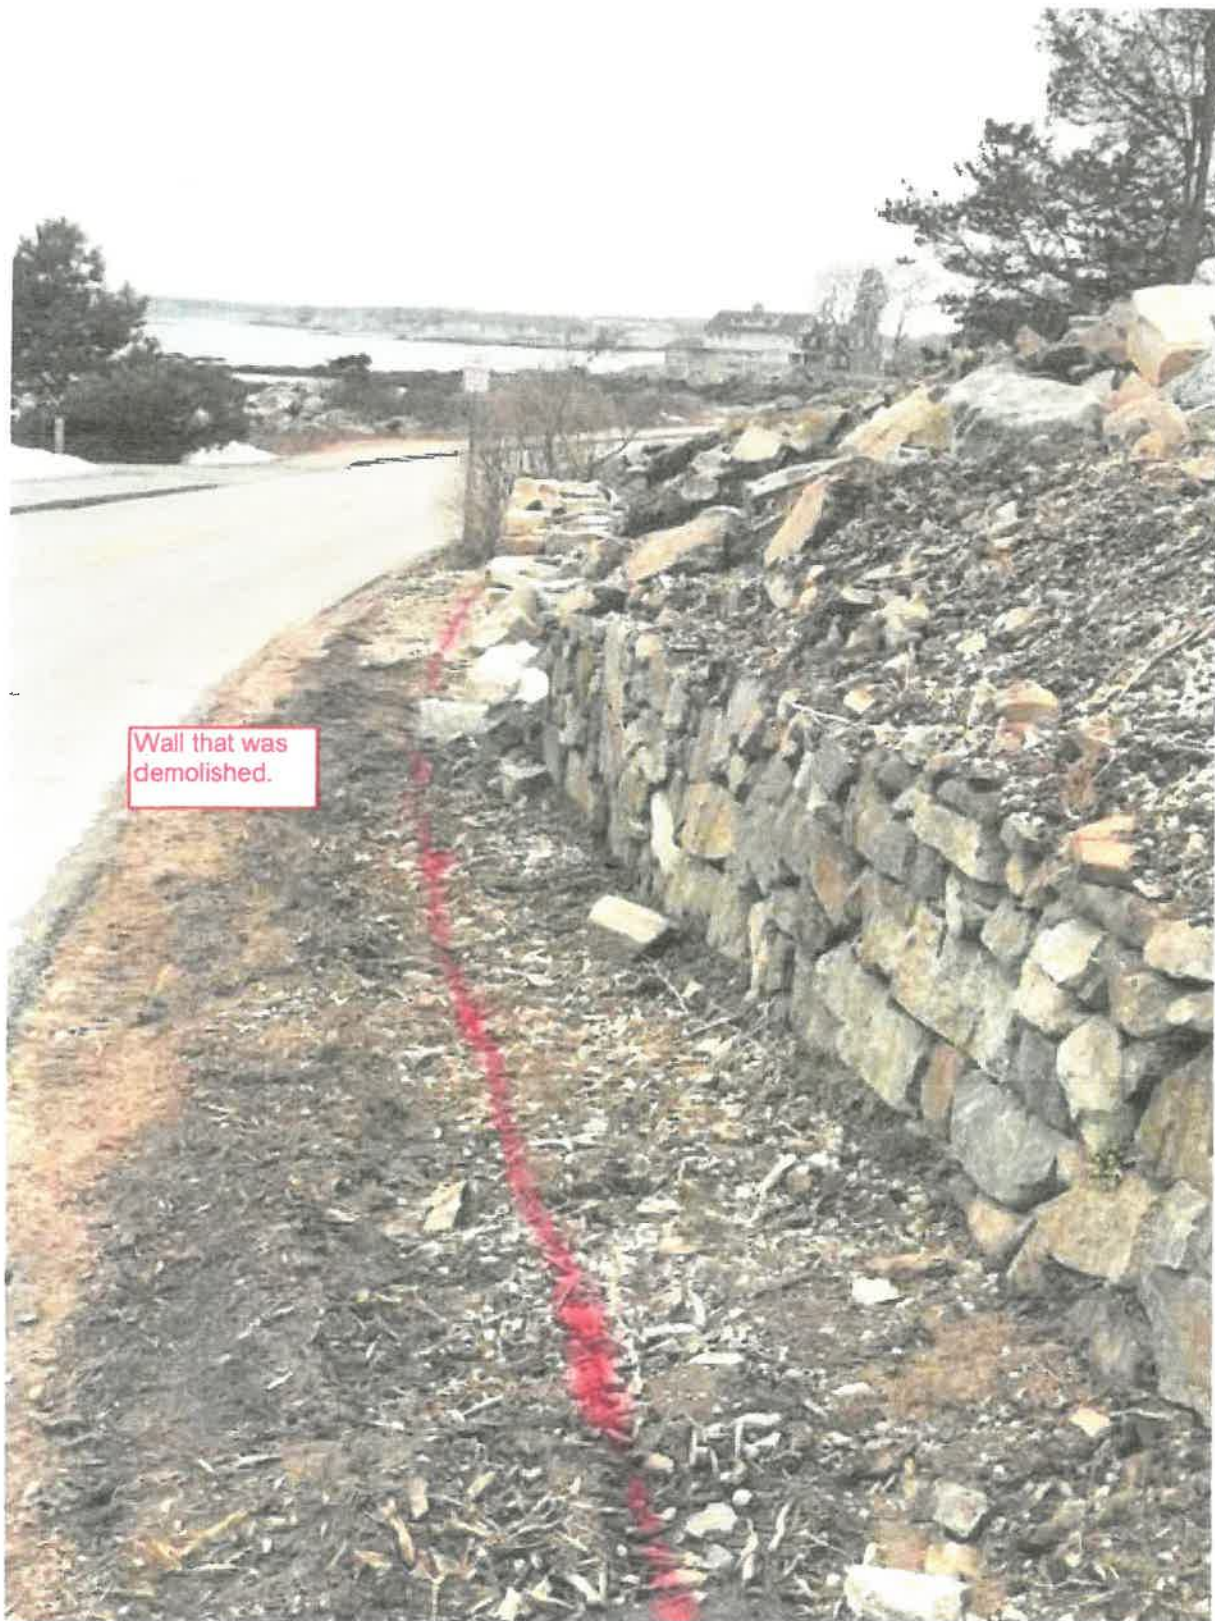
Wall that was demolished. Note location of wall relative to edge of road. The following photos show the new wall closer.
