KENNEBUNKPORT ZONING BOARD OF APPEALS
Administrative Appeal Application

Reason for Appeal: Lifting of Suspension of Permits without all corrective measures ordered being taken:

- (1) Resubmitted plot plan does not show demonstrate no increase in lot coverage. (2) Wall section A11 not built per submitted plans, and not to code. (3) Construction of rock walls A2 and A1 appears haphazard, and not to code.
(4) Unauthorized and unlawful work, including patio structure must be corrected. See Addendum for details as to 1-4.

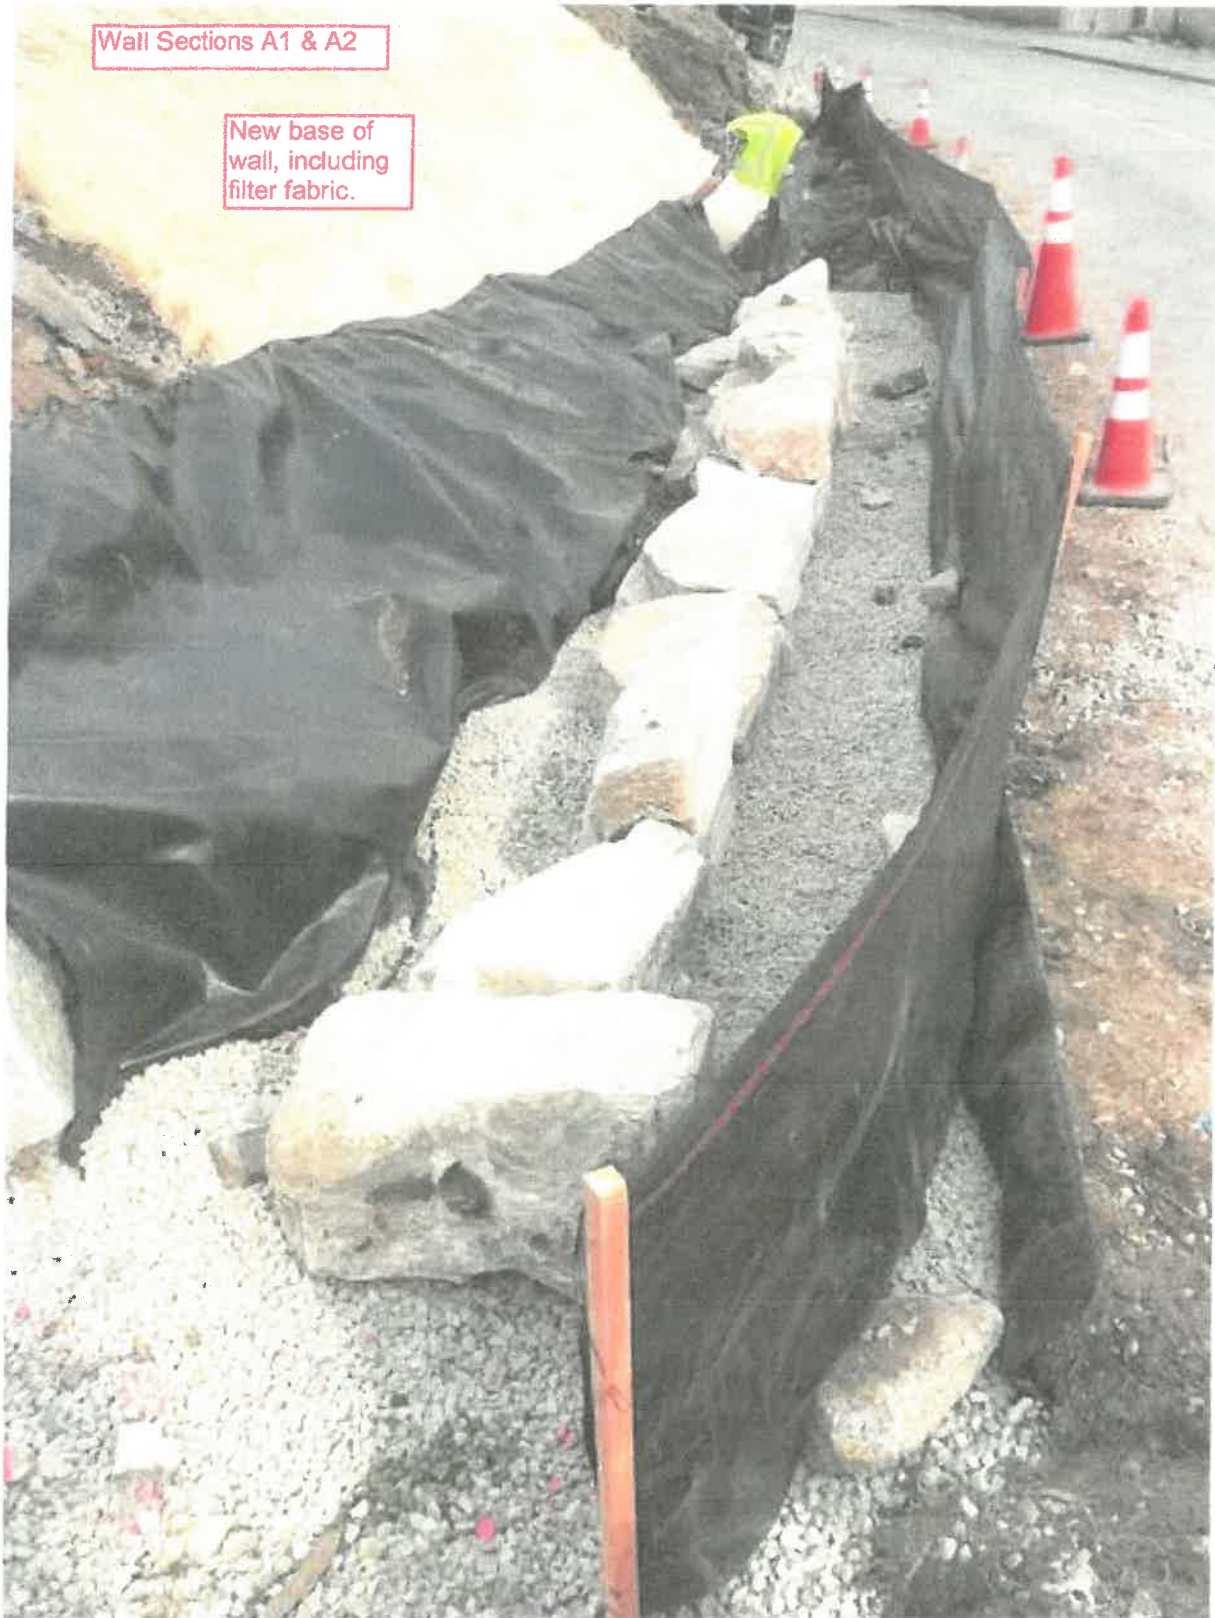
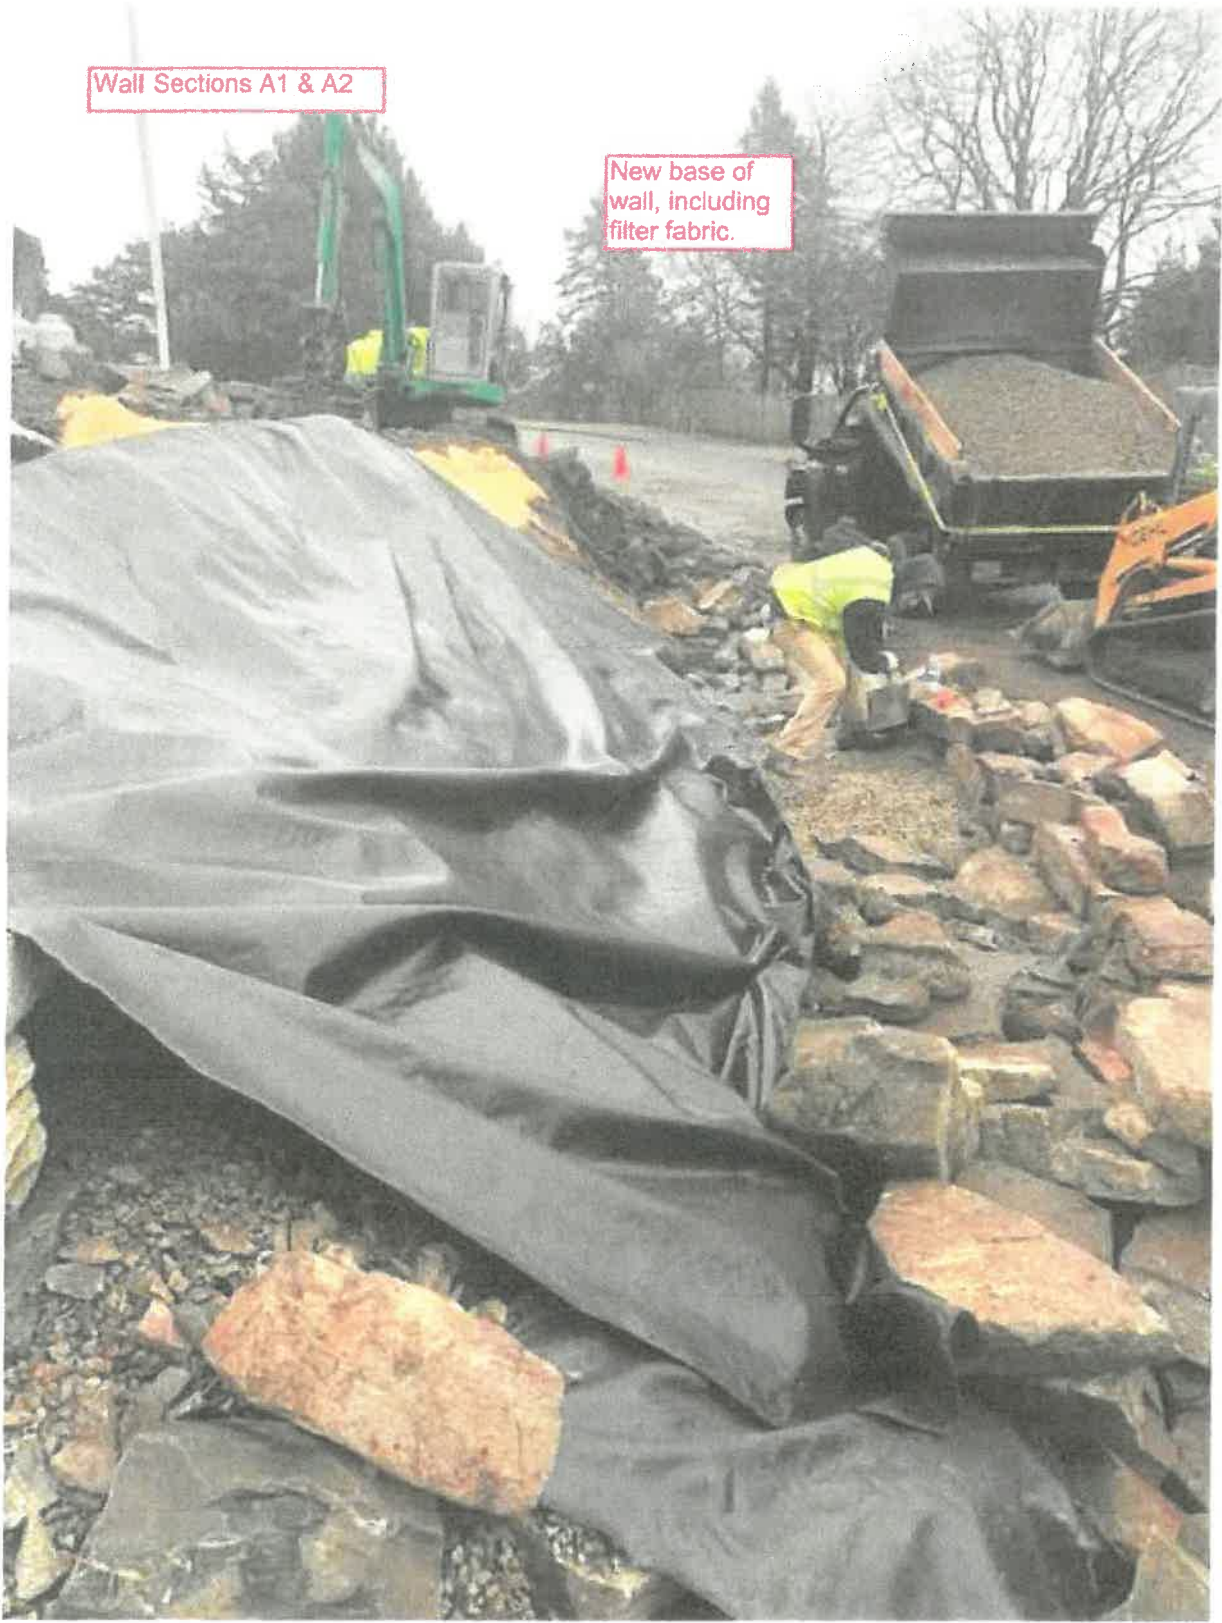
Wall Sections A1 & A2

New base of
wall, including
filter fabric.

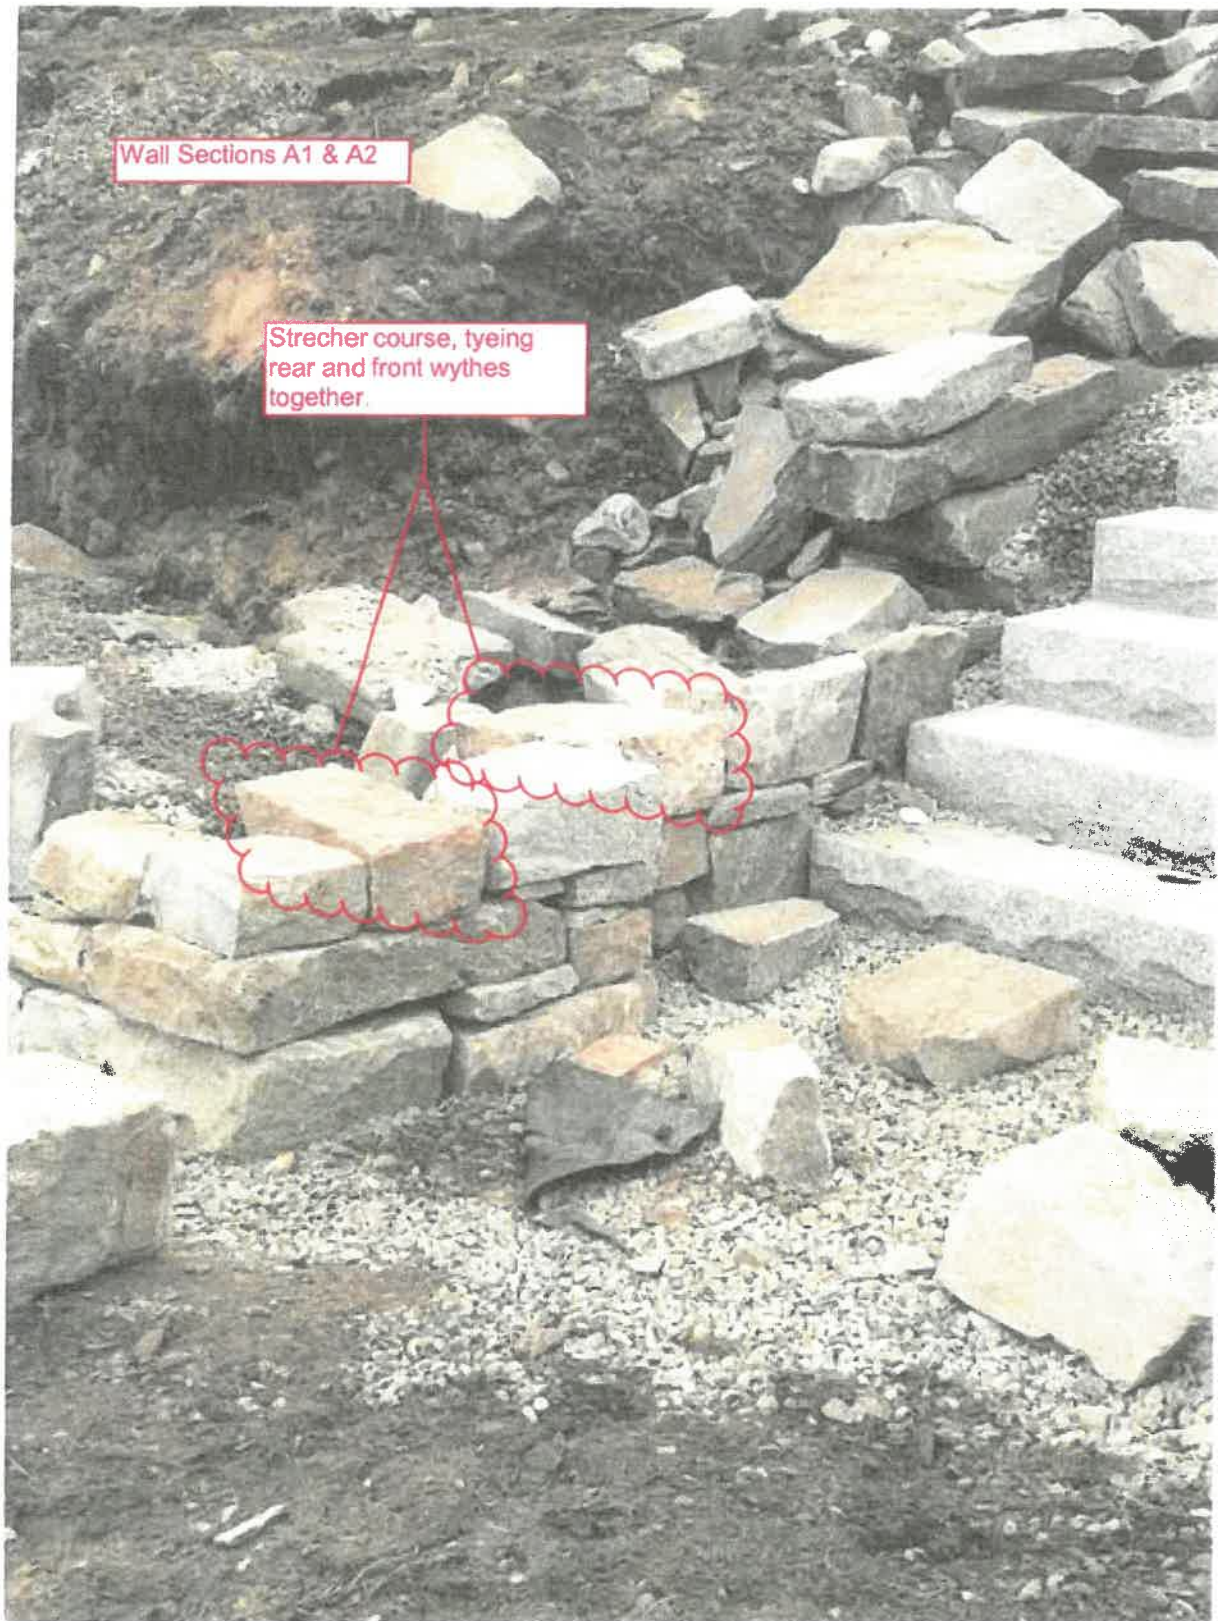
Wall Sections A1 & A2

Strecher course, tying
rear and front wythes
together.

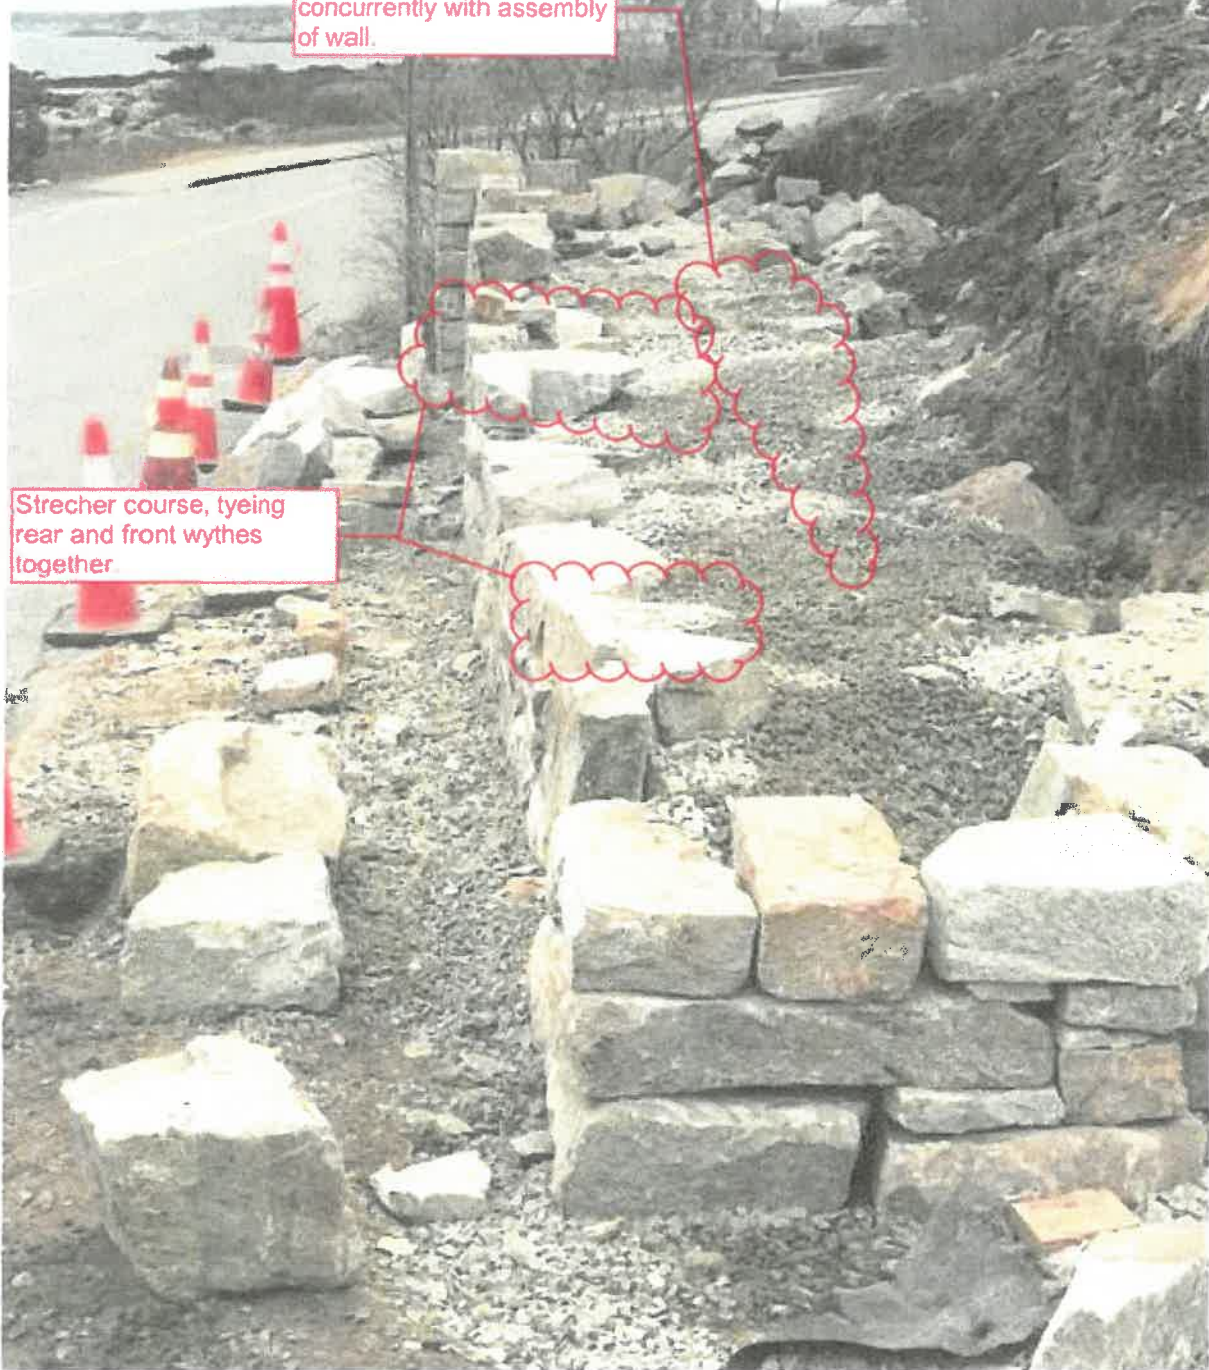
Wall Sections A1 & A2

Crushed stone placed
concurrently with assembly
of wall.

Strecher course, tying
rear and front wythes
together

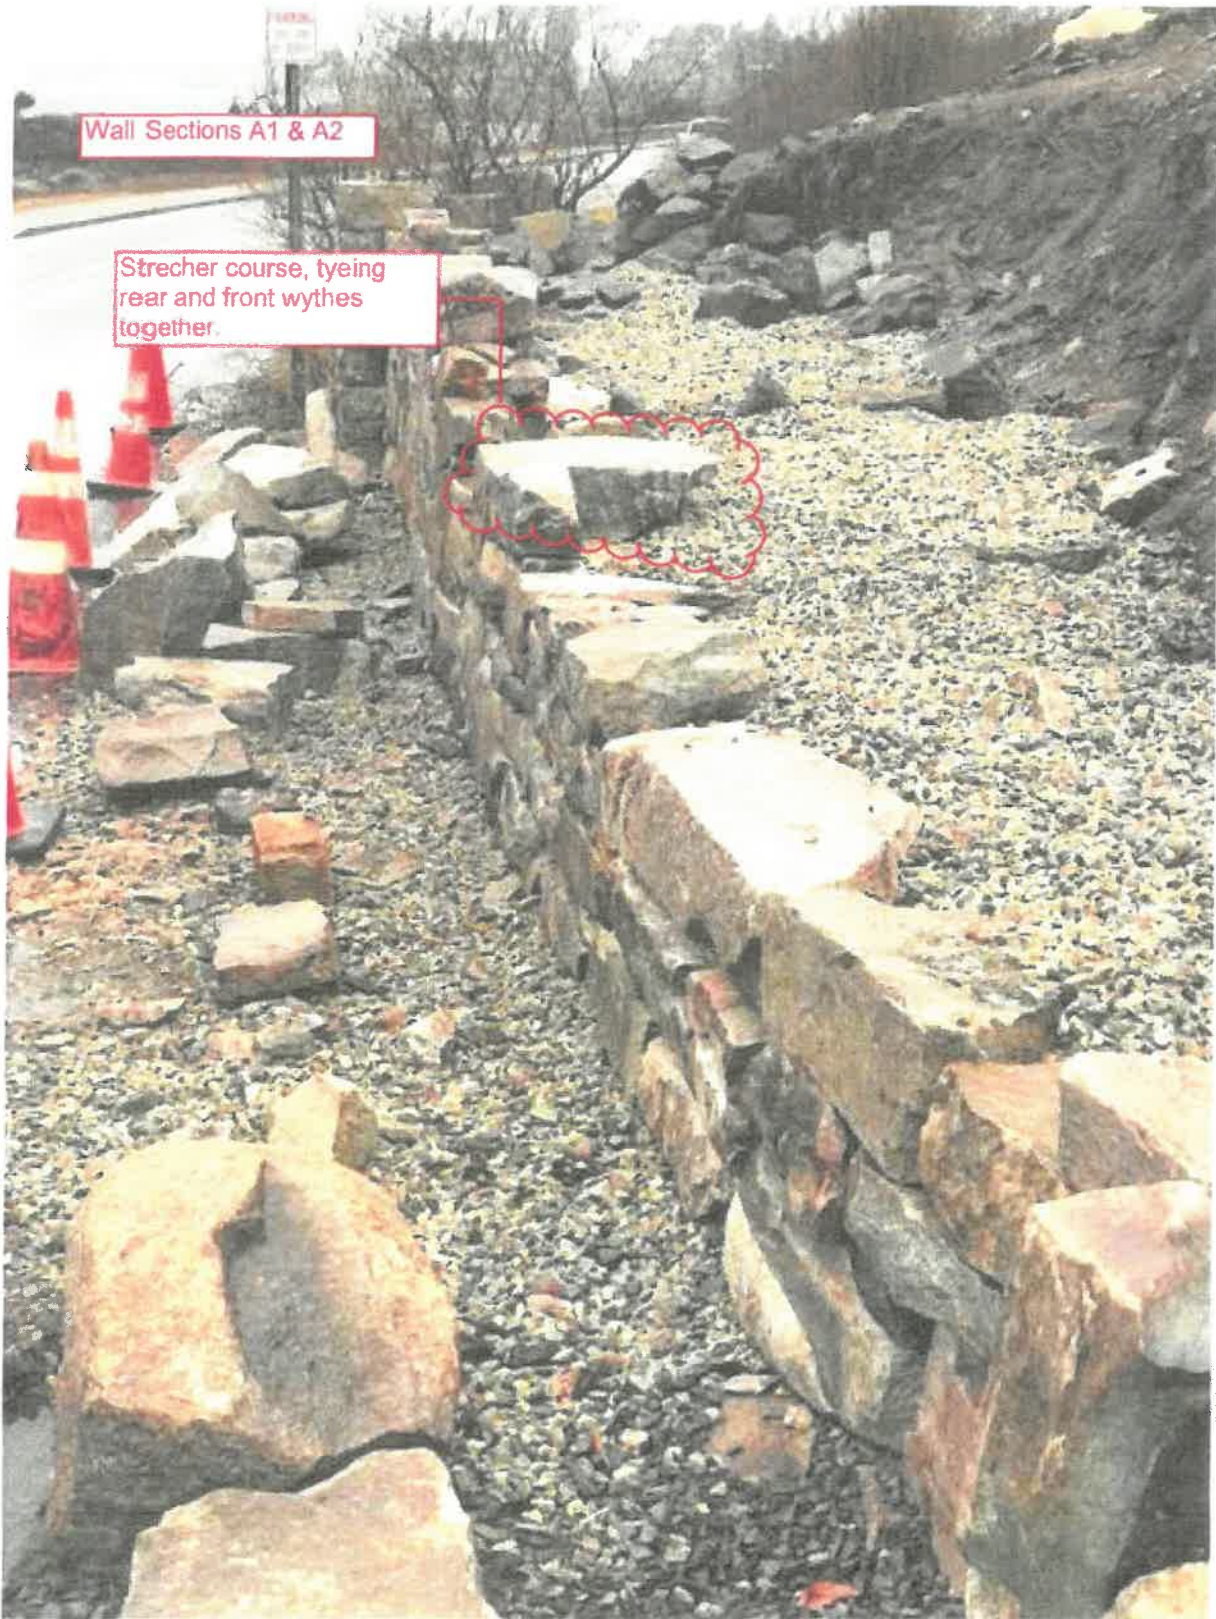
Wall Sections A1 & A2

Strecher course, tying
rear and front wythes
together.

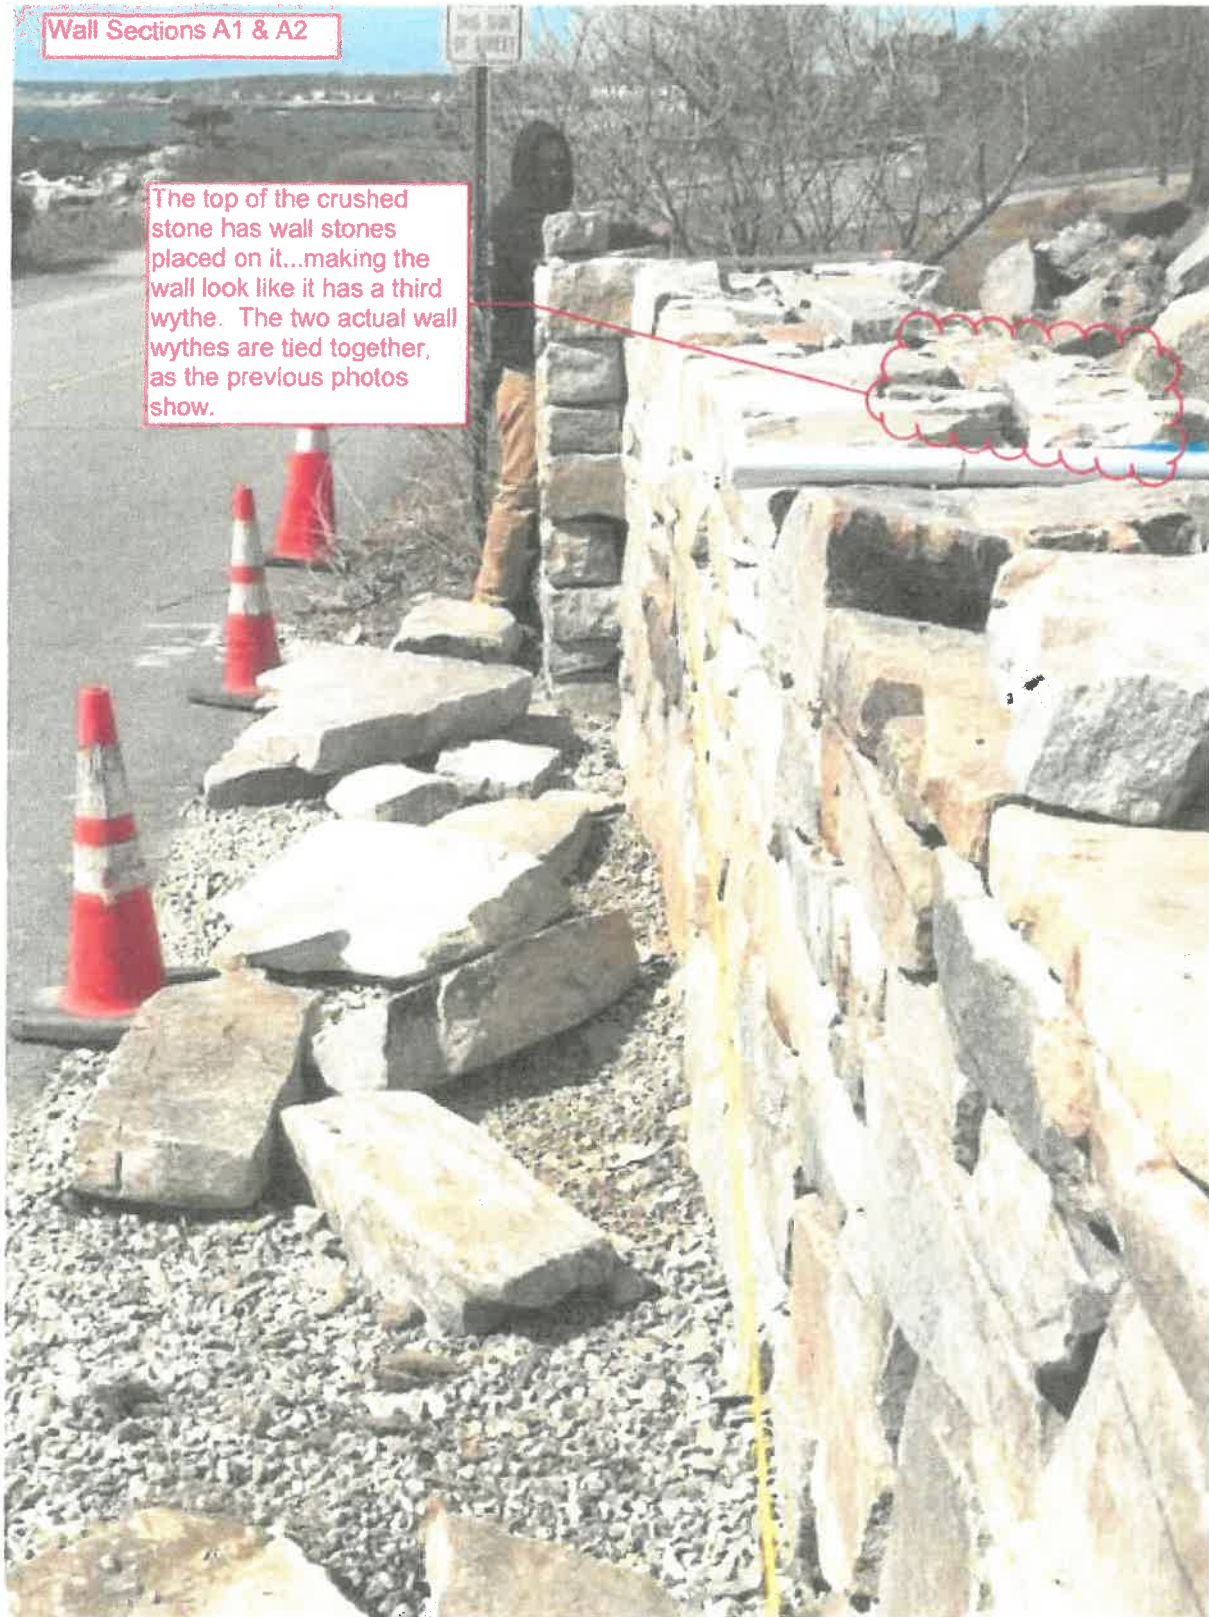
Wall Sections A1 & A2

The top of the crushed stone has wall stones placed on it...making the wall look like it has a third wythe. The two actual wall wythes are tied together, as the previous photos show.

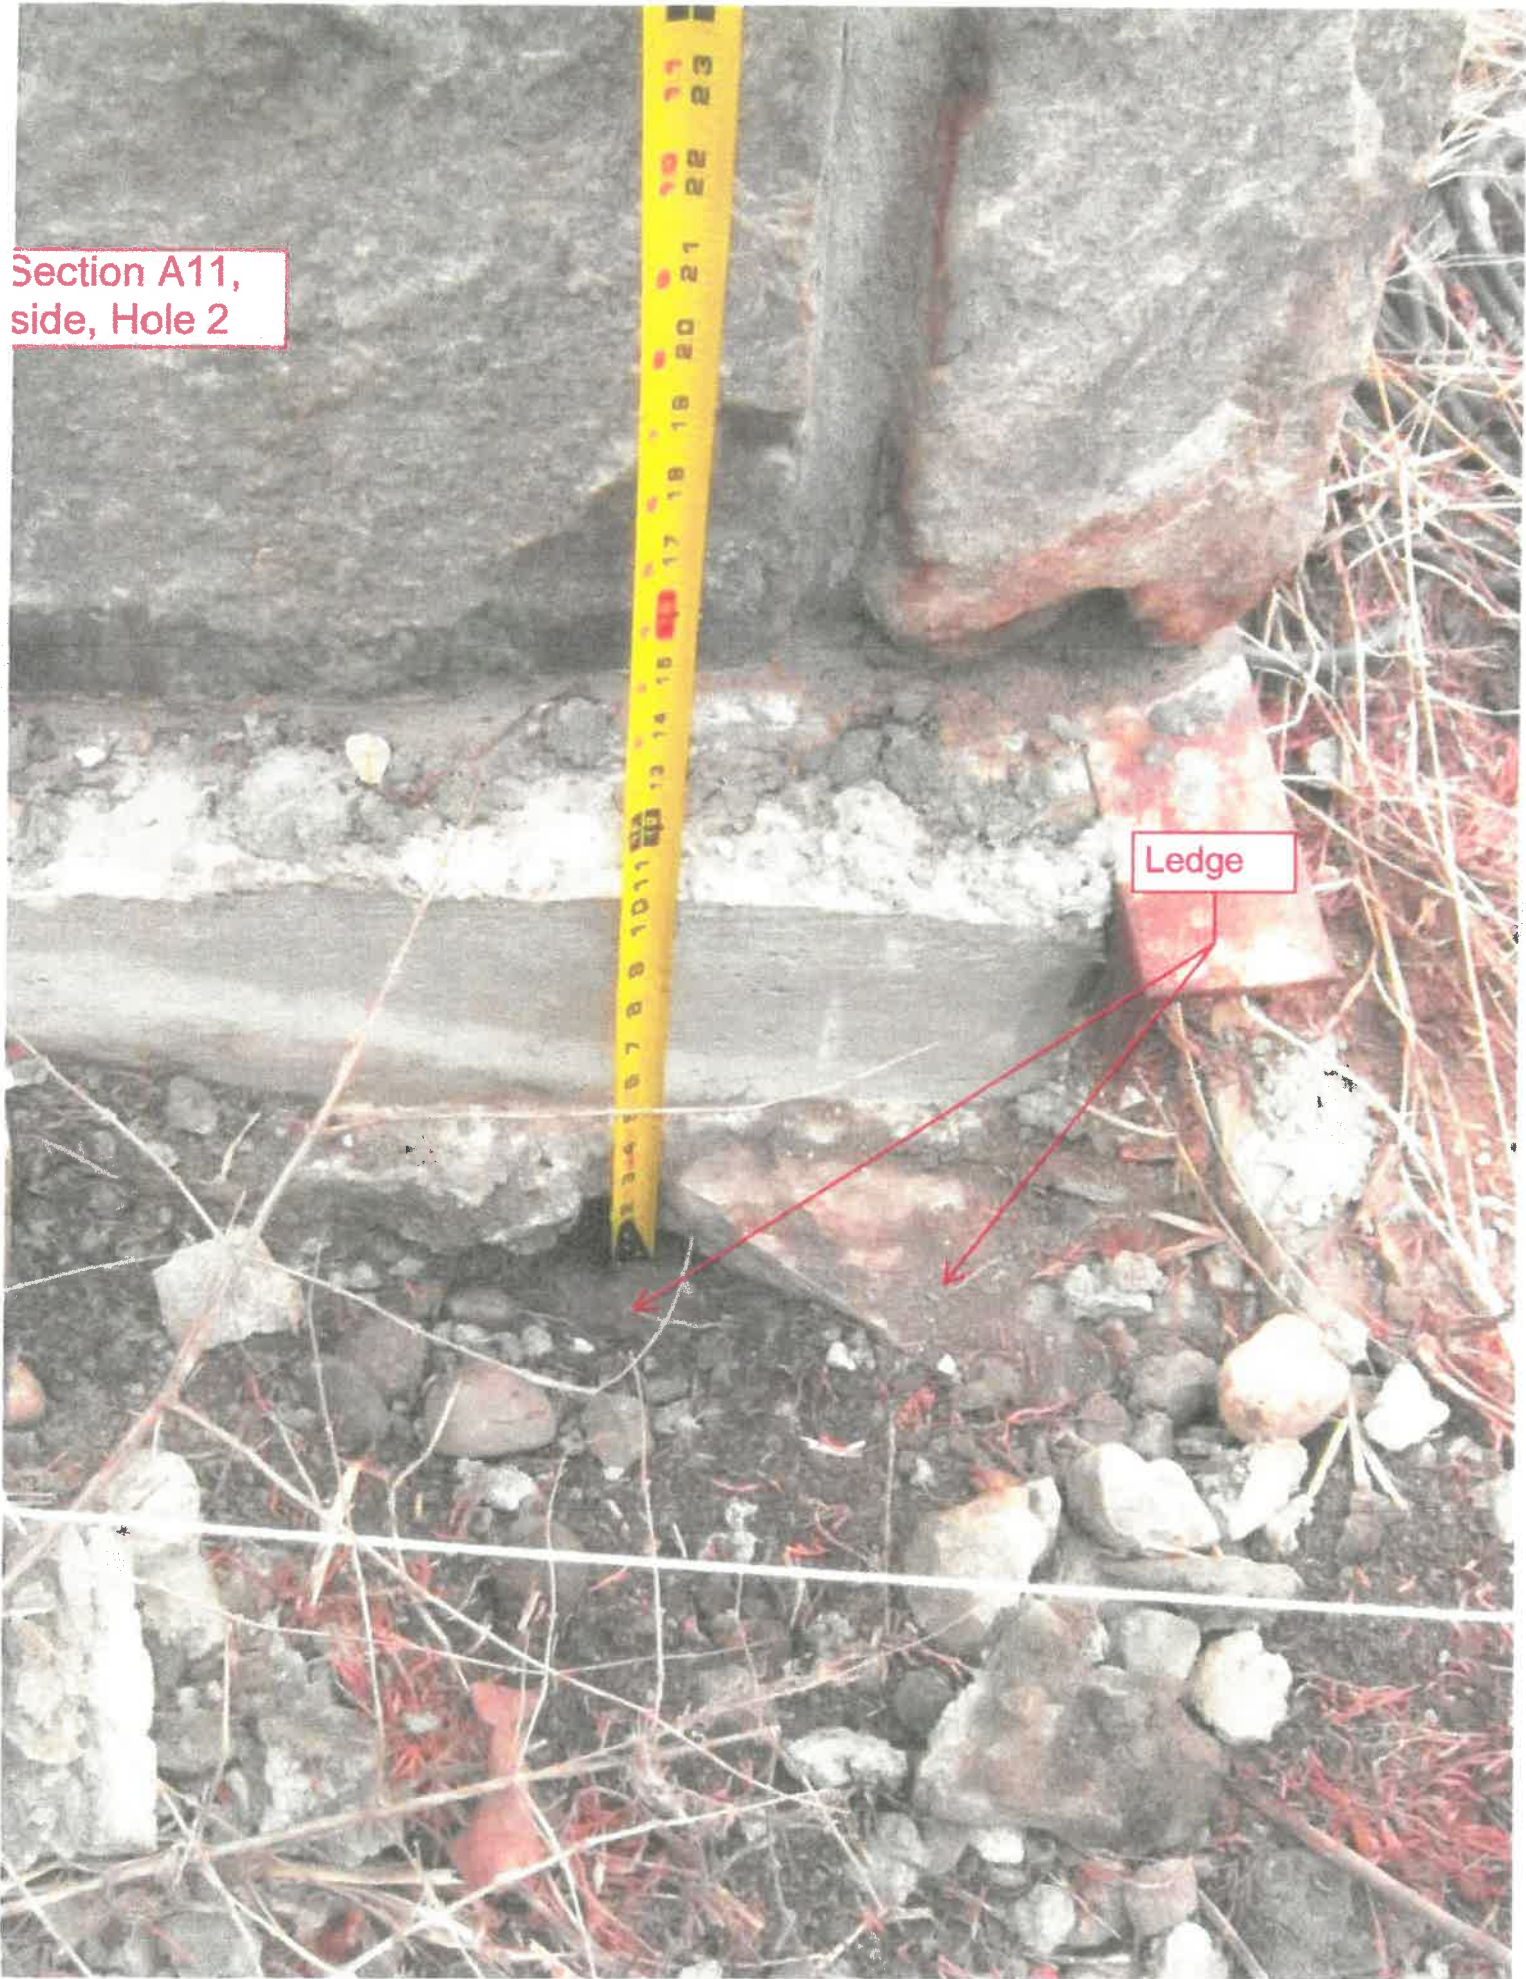
Section A11,
side, Hole 2

Ledge

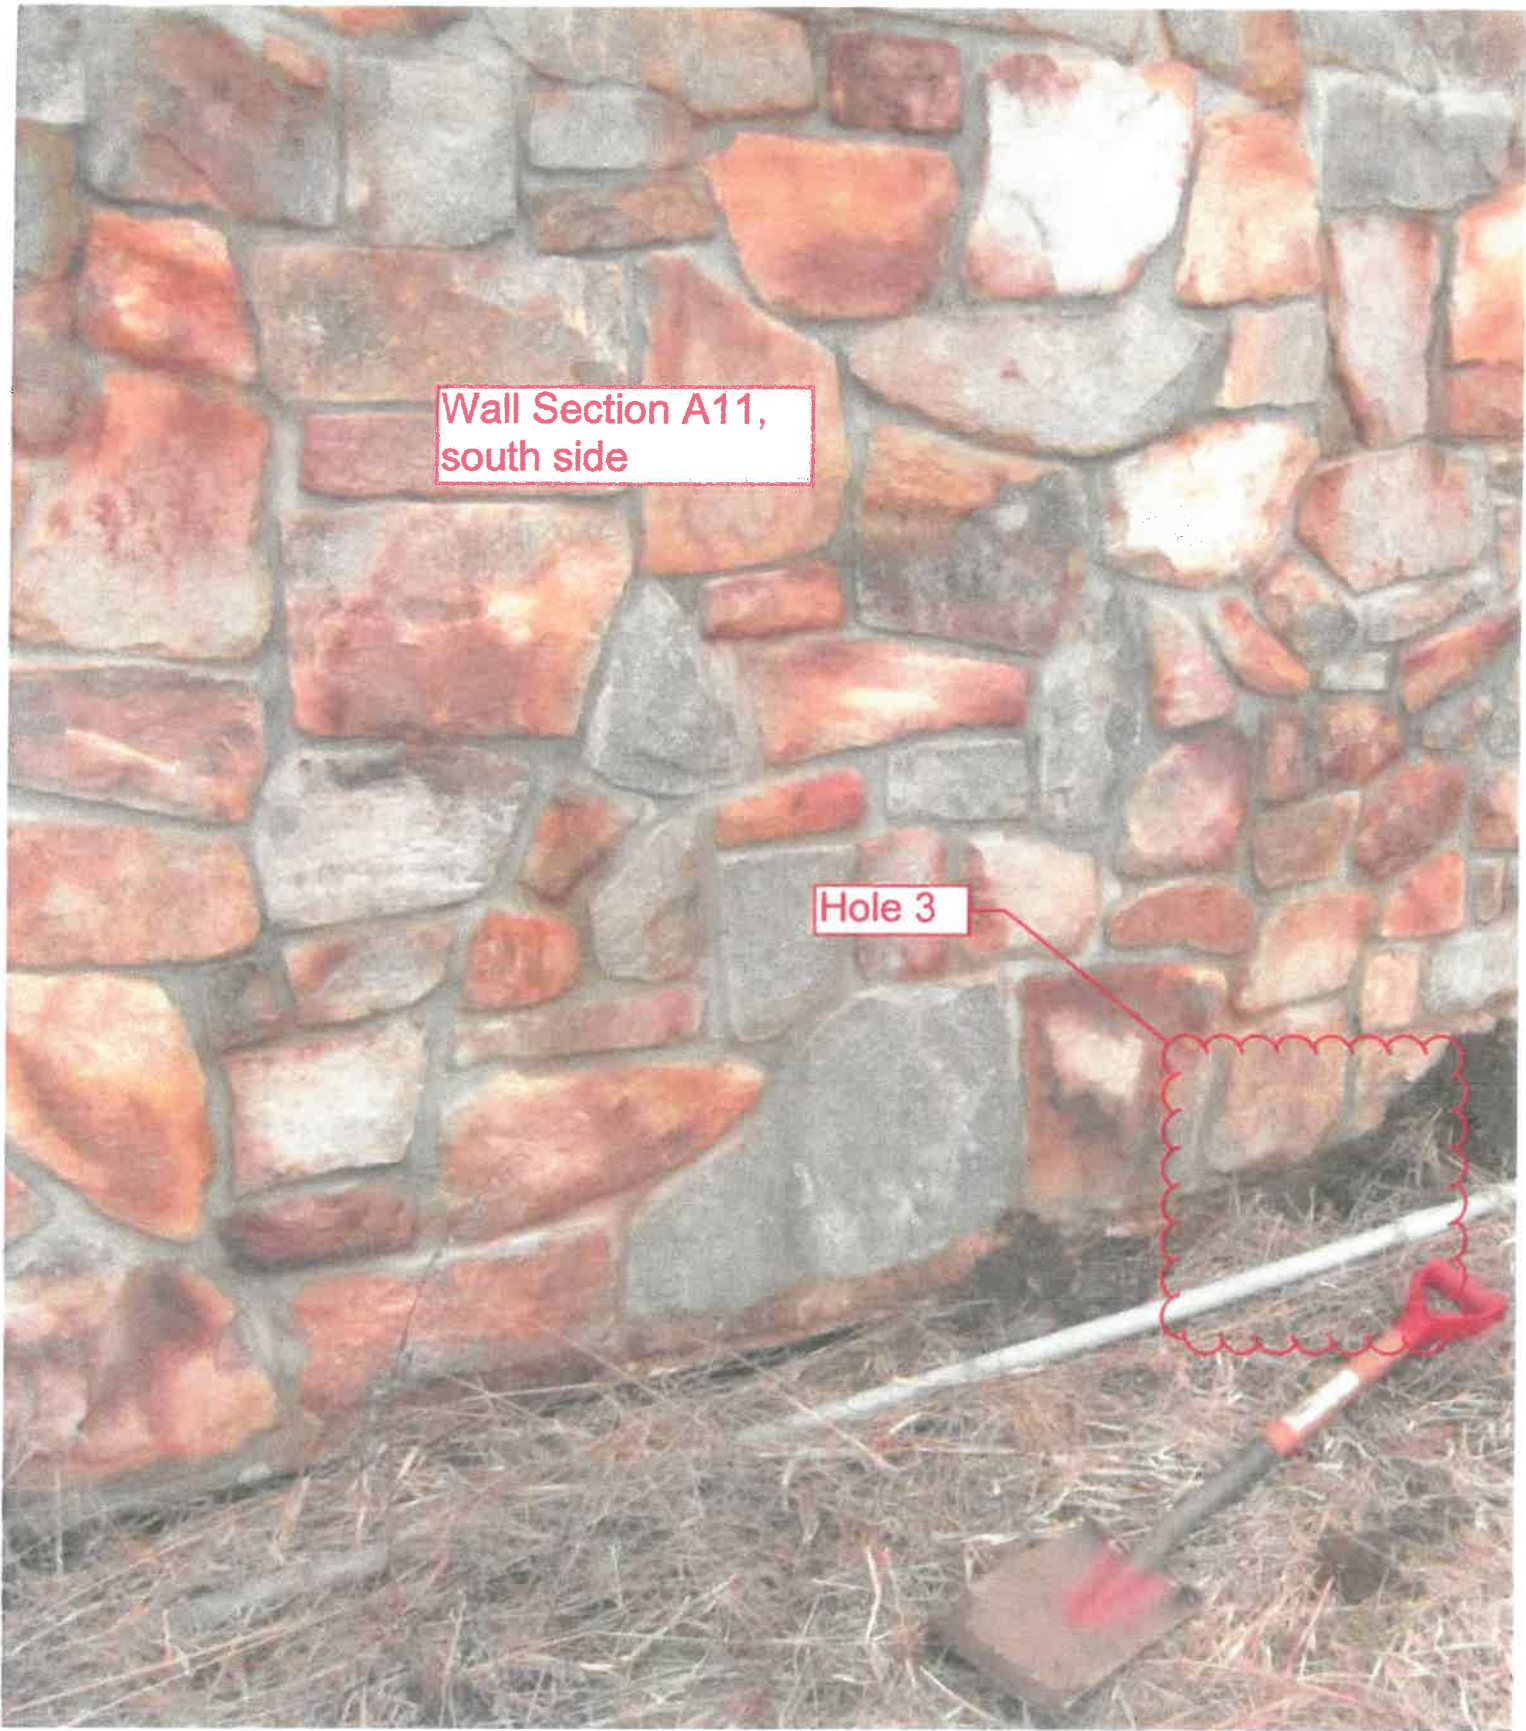
Wall Section A11,
south side

Remnant
formwork

Ledge

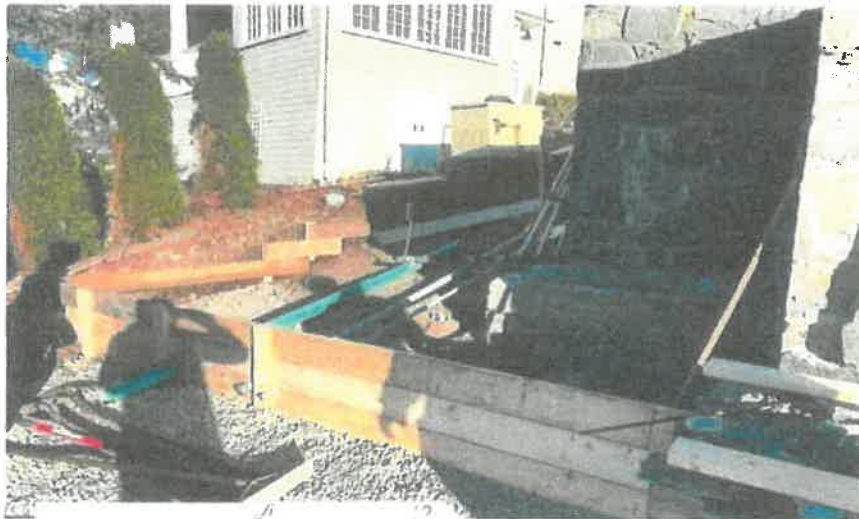
1. The formwork adjacent to the west property line is installed level.
2. The formwork has already been attached to the vertical support posts at the side.
3. The vertical height of the formwork relative to the shrubbery matches the conditions that are currently observed on site.
4. The southwest corner of the formwork extends above grade and this condition matches the field observation that the bottom of the existing installed footing is at grade level at the southwest corner.
5. There is a long stretch of level formwork at the south end of the formwork on the west side and then there are two footing steps farther to the north that are a short distance apart; this condition also matches current observations.
6. The caption below the photo confirms that the placement of concrete in the footing would occur within a few days.

Clearly this photo shows the formwork is in its permanent position prior to concrete placement and the caption indicates the placement of concrete occurred shortly thereafter.

More importantly, the photo dispels the notion that the wall footing is bearing on ledge or is connected to ledge. Existing grade is well below the bottom of the formwork.

"Forms in place for footing for block wall. Scheduled to be poured next week. The purpose of these walls is to gain valuable space above for the fire pit gathering area."

Therefore, based on the information available, PSE is of the opinion that the existing footing below wall A11 is not bearing on ledge nor is it connected to ledge.
